TIREY & ASSOCIATES, P.C.

CONSULTING STRUCTURAL ENGINEERS

March 22, 2011

RE: First Congregational Church Structural Condition Evaluation, Lebanon, NH

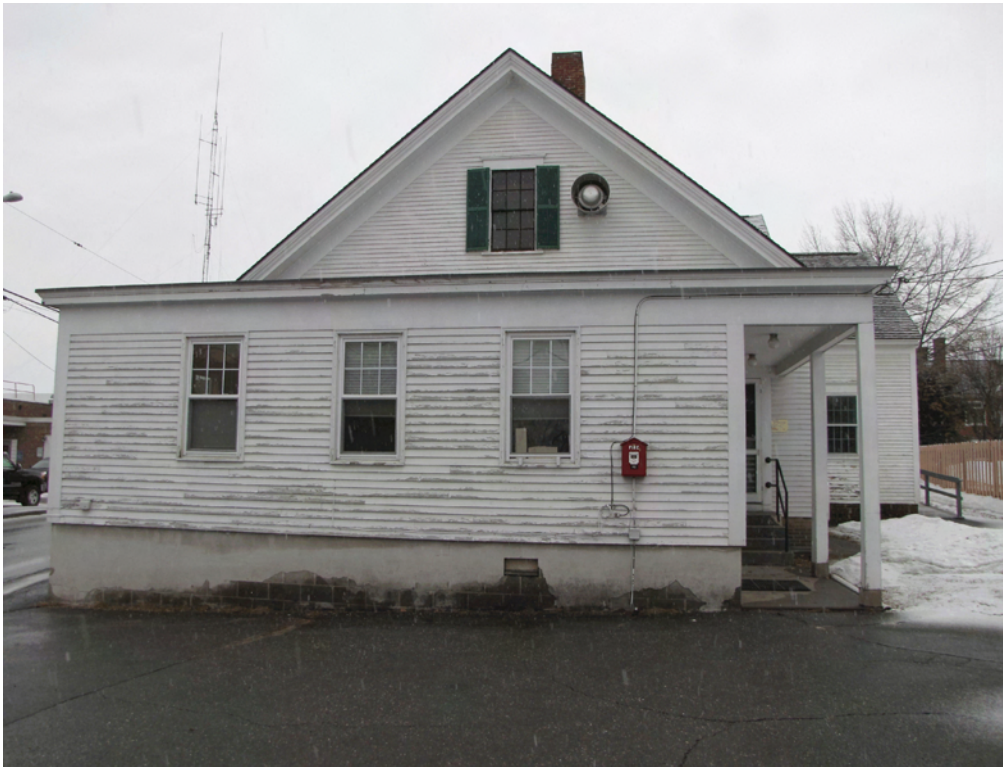
First, the exterior concrete masonry block foundation walls have cracks throughout many of the exposed mortar joints. The cement parging which covers the masonry block has partially fallen off the block, particularly at the bottom half of the south wall. This likely results from this parging being in the "snowplow zone", whereby the bottom of the wall is subject to exposure to salt laden snow and water, and even direct contact by snowplow blades. Thermal expansion and contraction of these walls can also lead to cracking. One spot on the east foundation wall, close to the southeast corner of the building, has the mortar fallen out of a vertical joint and the parging cracked. The presence of the cracks can permit water entry which, over the long term, leads to freeze-thaw degradation of the masonry block. The remainder of the existing parging should be removed and new fiber reinforced parging applied to the masonry block after re-pointing of cracked mortar joints.

Photo 009: View of south end of the building, at the 1960's addition. Note cement parking has partially cracked and fallen off the masonry block foundation.

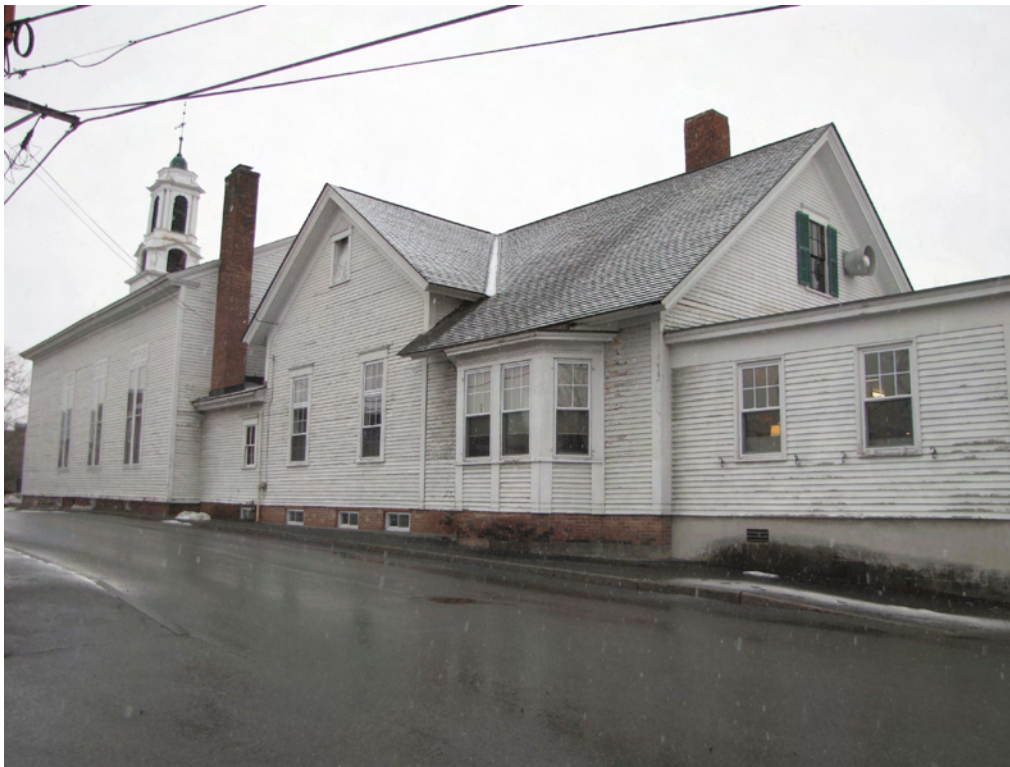
Photo 011: View of west side of building, along street and sidewalk. Note cement parking on 1960's office addition at right side of photo is deteriorated and partially fallen off block.

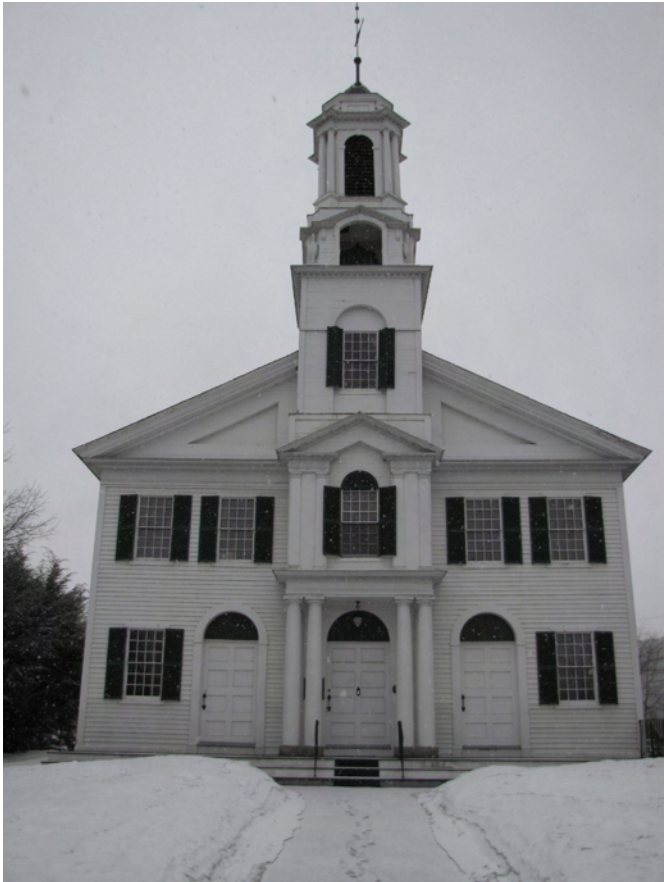
Photo 017: View of north side of building.

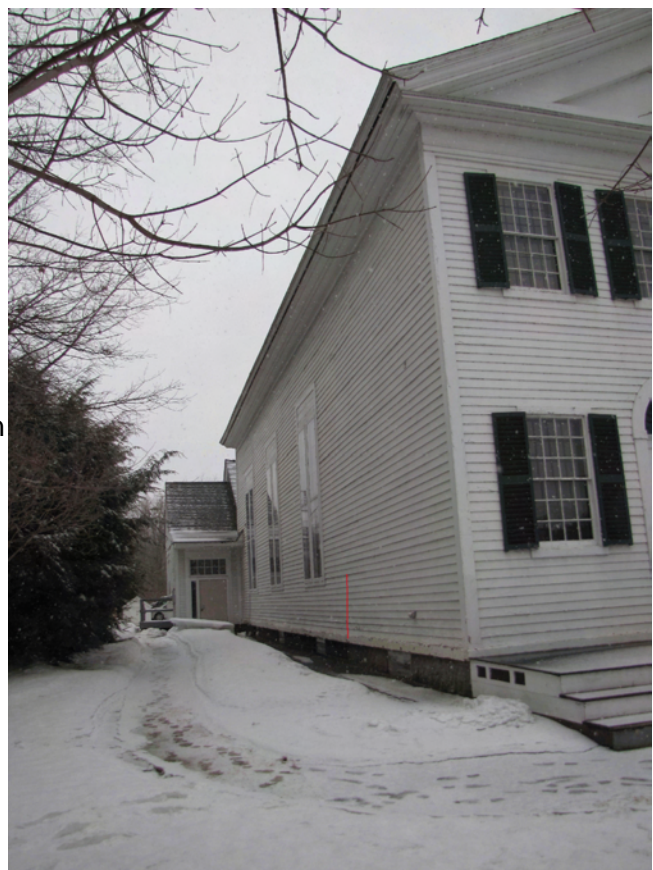
The east and west foundation walls for the sanctuary have brick supported on a concrete wall, for most of the wall length. The original foundations were likely granite stone which were probably removed and replaced with the brick and concrete. The use of two materials for the current foundations leads to the creation of a hinge point at the joint between concrete and brick. This means that the lower concrete portion of the foundation wall will behave like a retaining wall, needing to have a wider footing projection outside of the wall to engage more soil to resist the overturning forces created by the lateral soil pressure. The 4"± footing projection on the inside of the foundation wall suggests that the footing was not designed as a retaining wall footing, which could lead to excessive rotation of the wall under lateral soil forces. The east foundation wall is out of plumb, with the upper portion of the wall about 5/8" in from the base of the wall. It is likely that this out of plumb condition occurred during the backfilling of this wall. In order to insure the safety of the building foundation, it would be prudent to establish a monitoring program to determine whether the wall is continuing to move or rotate inward, or not.

Photo 020A: View of east side of sanctuary portion of building. Note change of foundation wall at red line from granite stone to brick on concrete.

The sanctuary foundation walls should be analyzed to determine if they are stable and their footings are adequate, given the observed wall rotation. This may require exposing the exterior footing projection at the east wall, if no existing drawing information is available that shows the sizes and possible reinforcing in the existing foundations. If footings are inadequate, then some form of remedial action will be required to stabilize the concrete and brick foundation walls of the sanctuary.

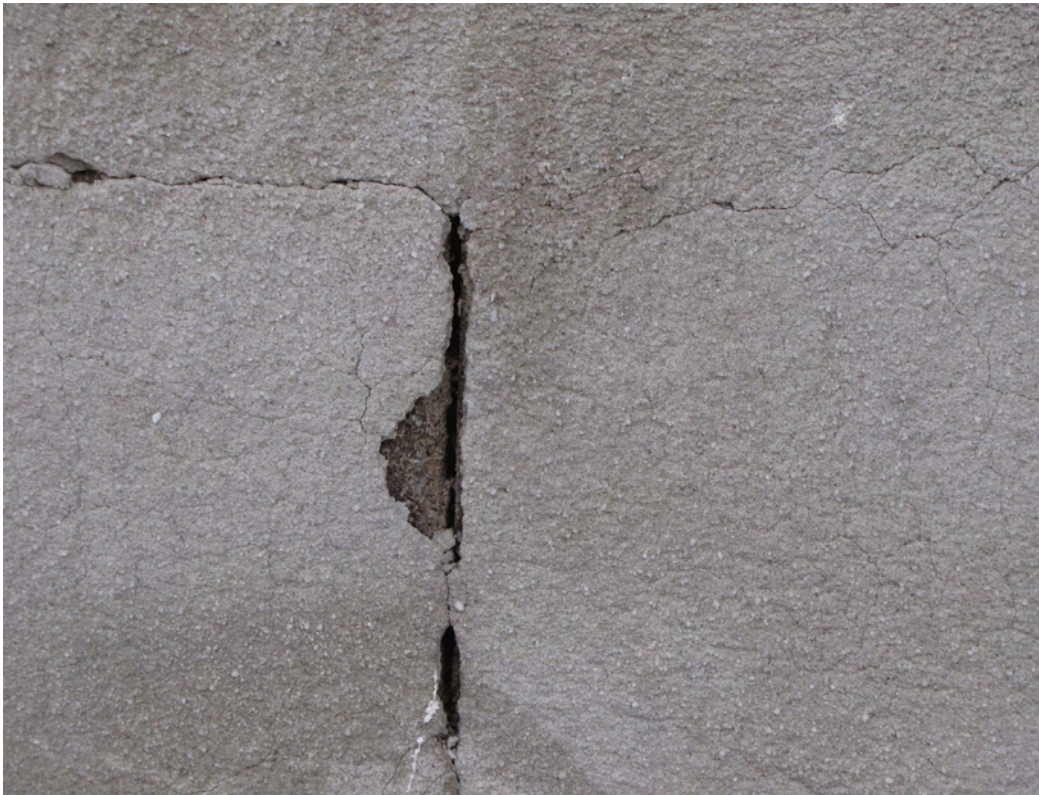
Photo 008: Closeup of 1960's addition deterioration of parging and cracks in masonry block foundation wall.

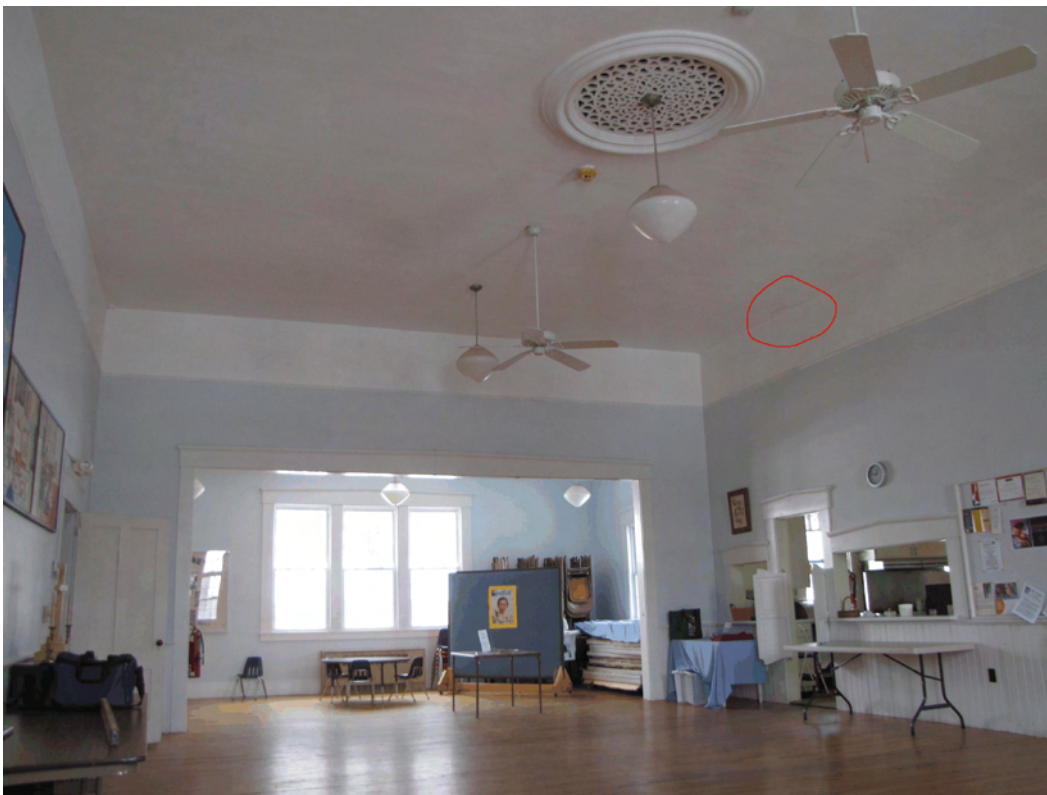
There is one small cracked area of plaster and lath ceiling in the fellowship hall. This does not appear to be a widespread problem, so a local repair of that crack should be sufficient.

Photo 092A: Interior view of 1920's addition looking east. Walls and ceilings are in good condition with sole exception of ceiling cracks in red circled area.

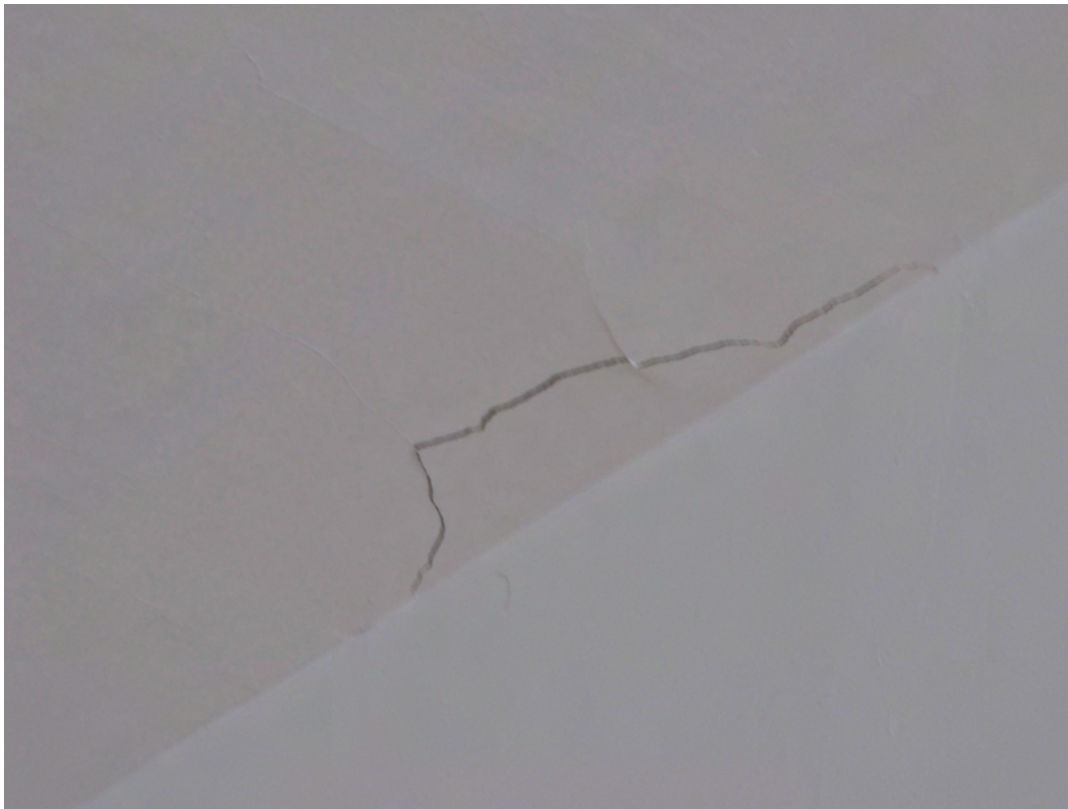
Photo 091: Closeup view of cracked plaster ceiling from Photo 092A.

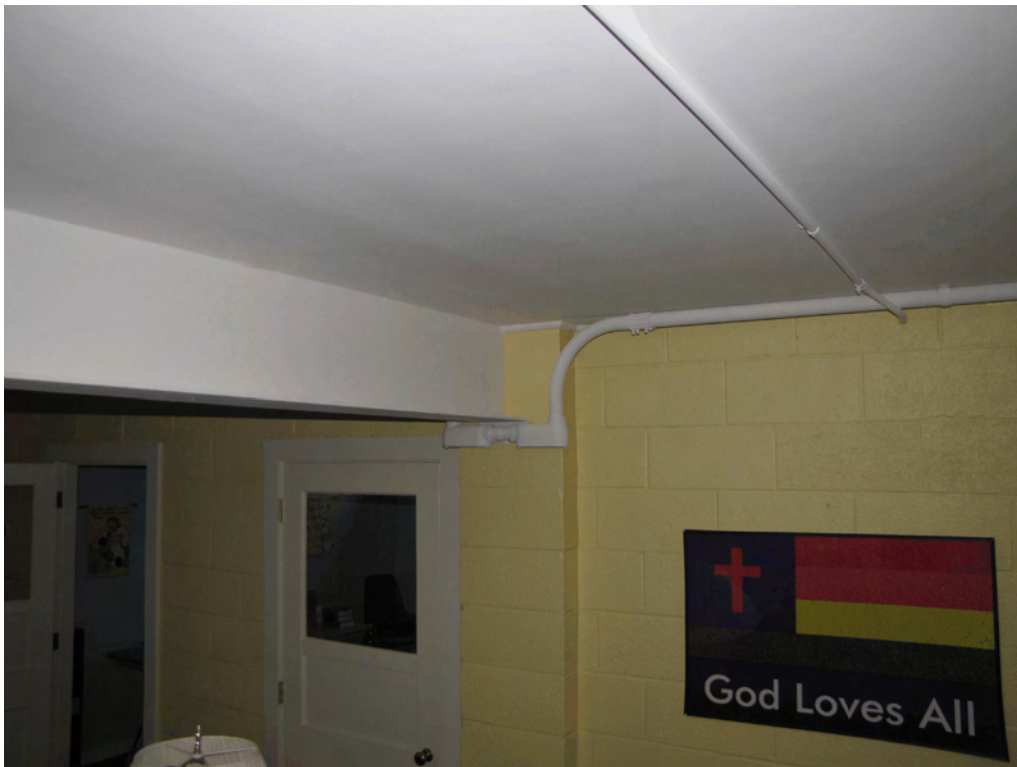
There are a couple of minor issues or observations to be aware of, but which are not affecting the structural safety of the building. First, there is a hump in the fellowship hall floor that is located at the steel beam visible from the lower level. The hump has been created because the floor joists have been framed into the side of the steel beam, with the top of the joists originally at the top of steel beam or at the top of a wood plate on top of the steel beam. With this original construction arrangement, when the wood shrank as it dried out, the top of the joists shrank downwards while the steel beam did not, resulting in the hump in the floor.

Photo 085: Lower level of 1920's addition showing a portion of the steel floor beam projecting below the ceiling. Hump visible at the top side of the floor, occurs at this floor beam.

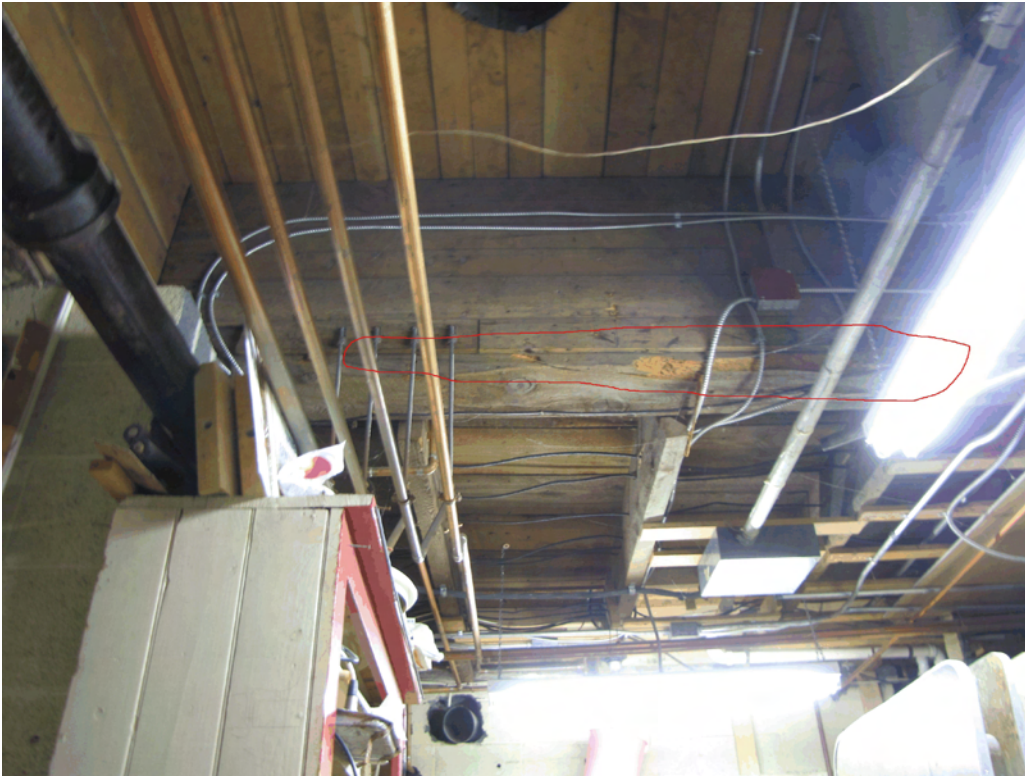
There is a basement connector between the fellowship hall and the sanctuary basement. One of the heavy timber wood floor beams has been damaged by powder post beetles, which burrow into and eat the wood fiber. It appears that there may still be some ongoing bug activity, so having the wood treated by a pest control professional would be advised. Because the floor beam has a relatively short span, the depth of the damage does not appear to have compromised the ability of the wood beam to carry the applied loads.

Photo 084A: View of bottom of main floor framing at connector area between sanctuary and fellowship hall showing floor beam with powder post beetle damage in red circled area.

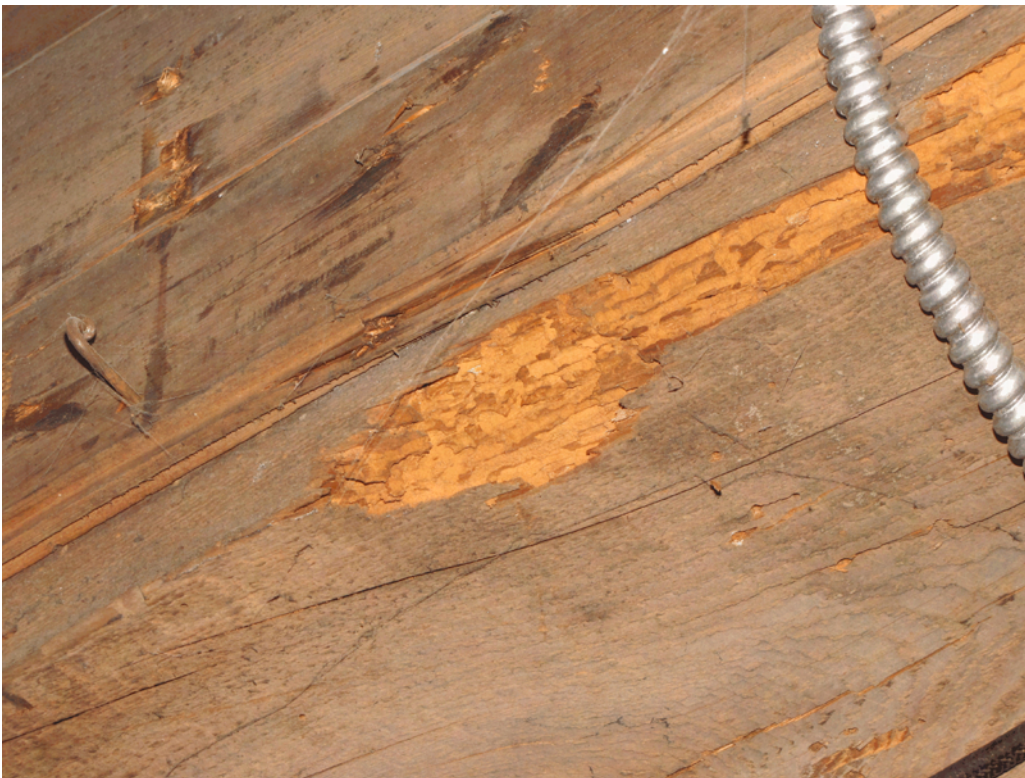
Photo 083: Closeup of damage to wood floor beam by beetle infestation.

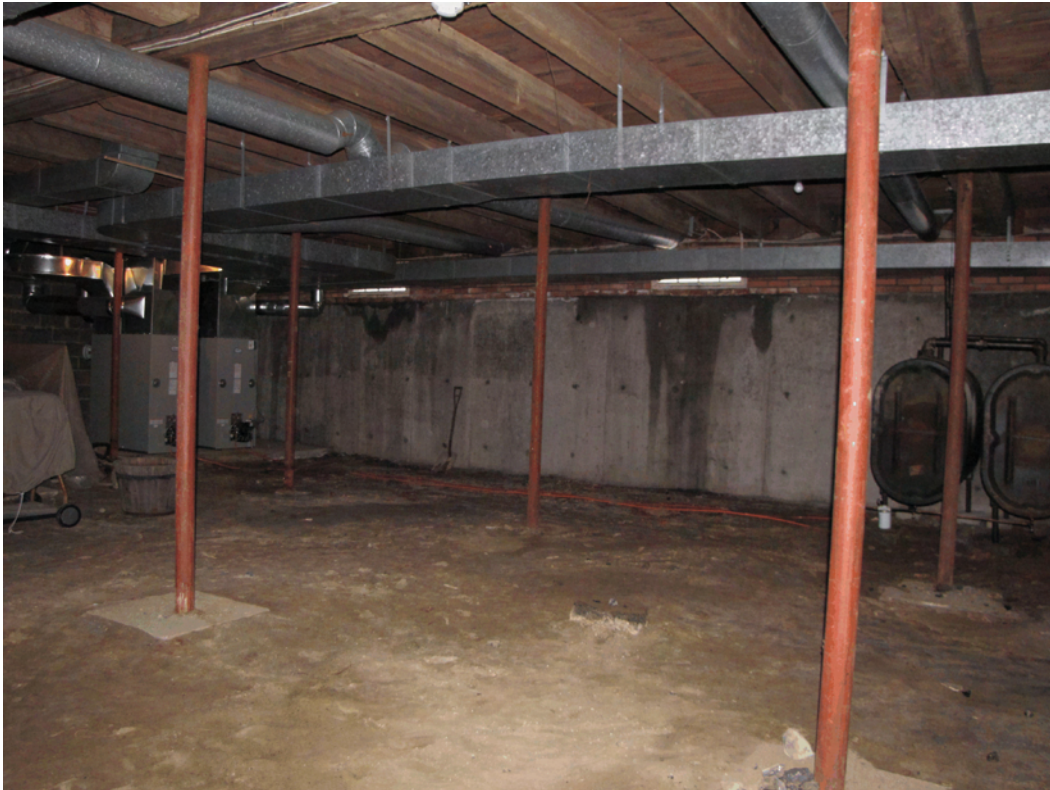
The footings for the basement Lally columns are 2' x 2' square, with their thickness not know. A quick calculation of the soil bearing stress for the column with the maximum tributary floor area, shows the soil bearing pressure under full design load to be about 8,500 pounds per square foot (psf). This bearing pressure is excessively high for soil, but would be appropriate for bearing on ledge. These

Photo 071: View of basement area beneath sanctuary, looking southwest. Note small size of footings which are flush with the soil grade.

small footings should be replaced with footings, properly sized for the type of soils supporting the footings.

Interior spread footings in the sanctuary basement should be replaced with larger footings, with sizing based on a numerical structural analysis. This analysis would also provide the opportunity to verify if the existing Lally columns have sufficient strength to carry the full design load.

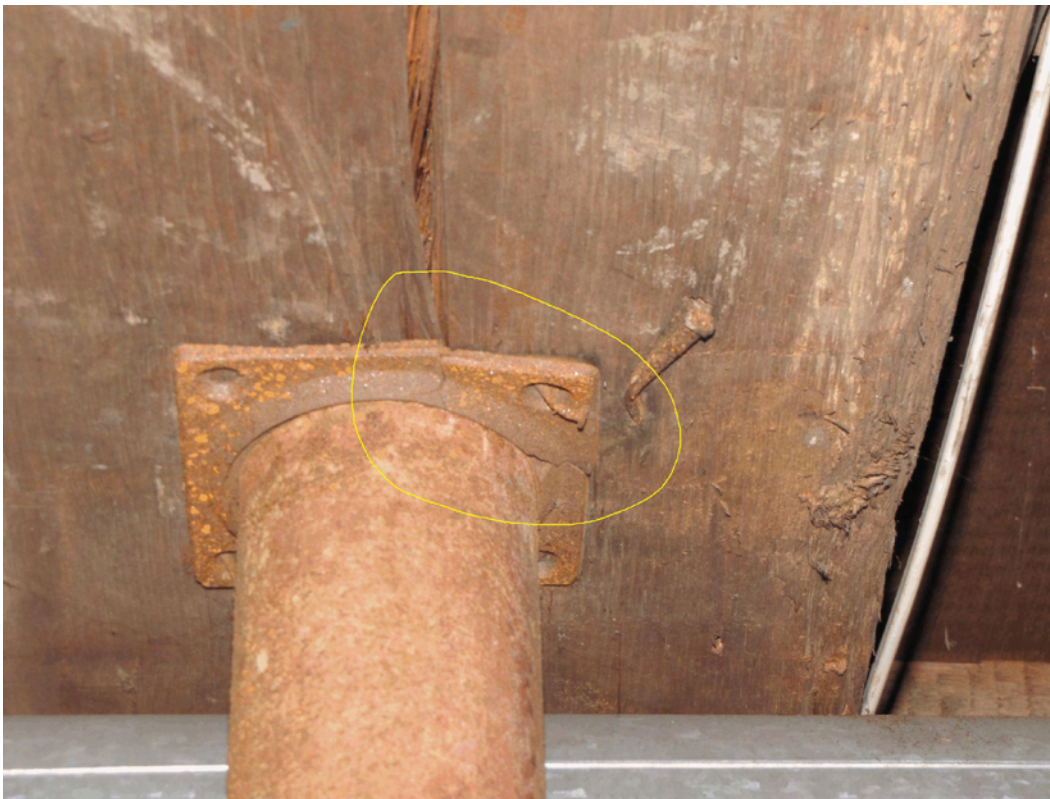
Photo 073A: Closeup view of sanctuary basement lally column support where the cap plate is cracked and displaced. The cap plate should be replaced.

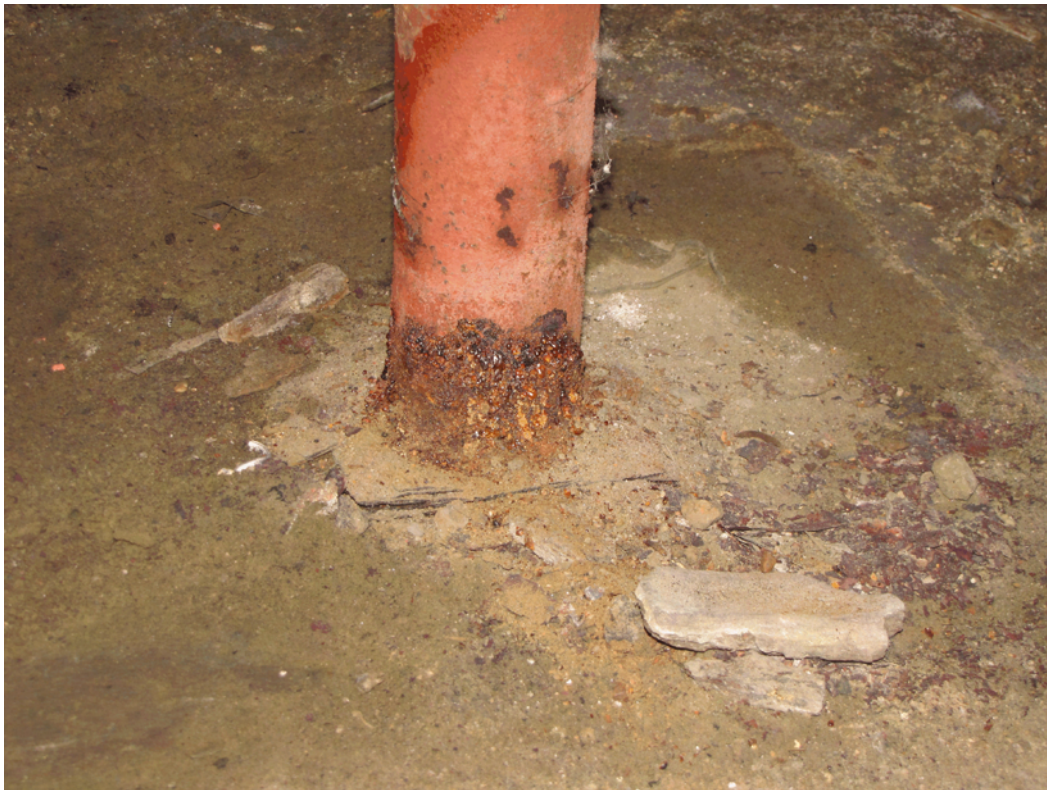
The steel Lally columns which support the heavy timber wood floor beams have varying degrees of corrosion at the bottom of the columns due to moisture migration from the dirt floor basement space. The column adjacent to the two hot air furnaces in the basement space is particularly bad. A portion of the steel jacket encasing the concrete core has corroded away for at least a third of the circumference of the pipe column. Some of the concrete has also spalled out from inside the steel jacket. This Lally column should be replaced. The remainder of the columns which have some corrosion present should be cleaned and painted with a corrosion inhibiting paint. One of the Lally columns has a cracked cap plate which should be replaced. The cap plates on the Lally columns are generally small in size and will produce bearing stresses on the wood which are in excess of its capacity, when under full design load. There are currently no signs of crushing failures of the wood fibers associated with excessive bearing pressures. This is due to the fact that the dead load is relatively light and the live load on the floor is infrequent and has a short time duration.

Photo 078: Closeup view of sanctuary basement lally column base with corrosion.

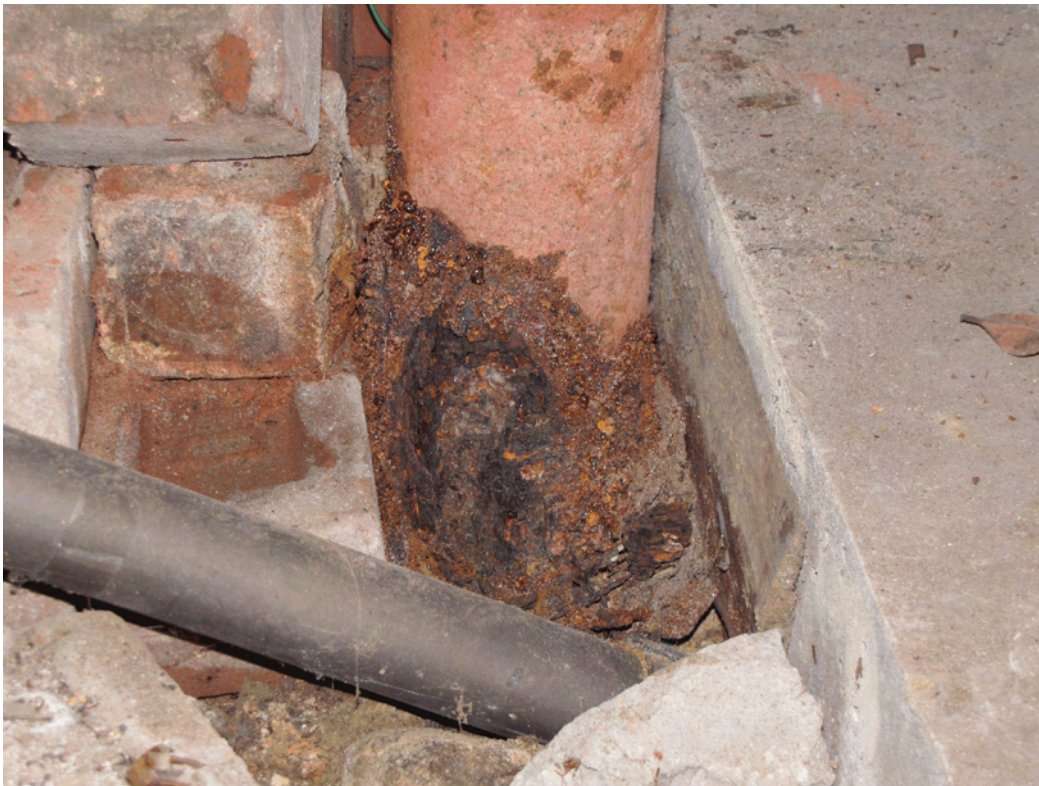
Photo 079: Closeup view of lally column base by furnaces with severe corrosion and material loss - steel jacket and some inner concrete.

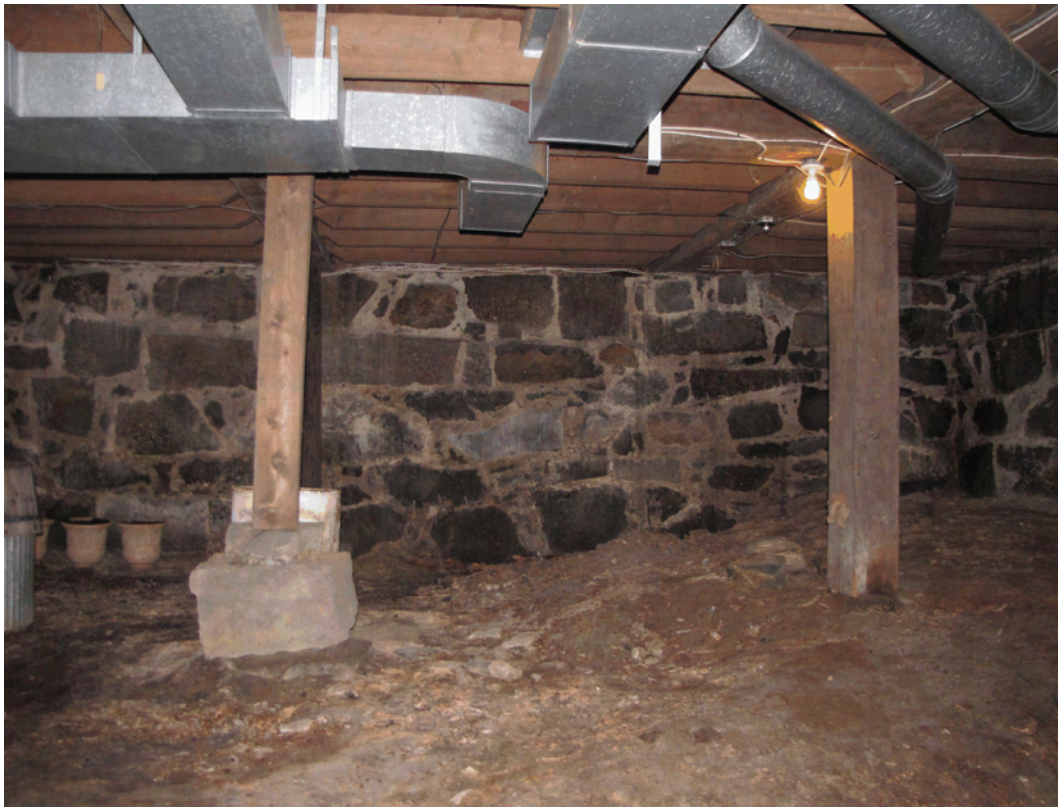
There are several wood posts still supporting the main floor structure, with these post generally at the north end of the basement space. One post in particular is offset from its original position and is out of plumb. This same post bears on dry stacked granite stones. It would be prudent to replace this post with a new steel column, or Lally column if sufficient capacity is available, and a properly sized new concrete footing.

Photo 074: North end of sanctuary basement showing two of four remaining wood posts. Note raised soil grade in right corner. Mortared stone foundation wall appears to be in good condition.

Replacement of the remaining wood columns in the sanctuary basement with new steel columns and footings, properly sized to carry the loads, is recommended at such time that the basement space is converted to utilized space. Conversion of the basement space to occupied space will be driven by principally egress and fire safety design requirements.

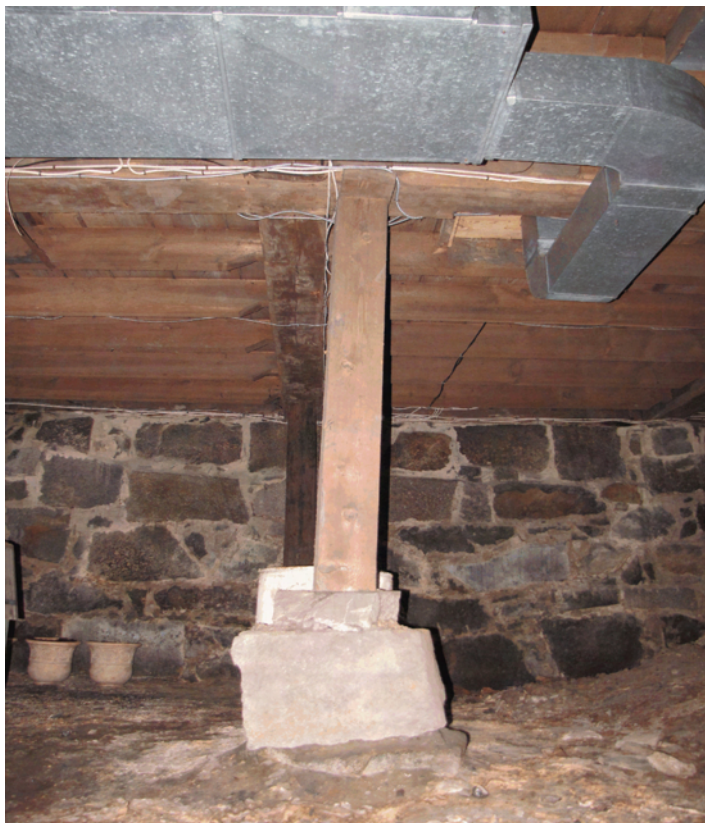
Photo 076: Wood post at north end of sanctuary bearing on stacked stones and out of plumb.

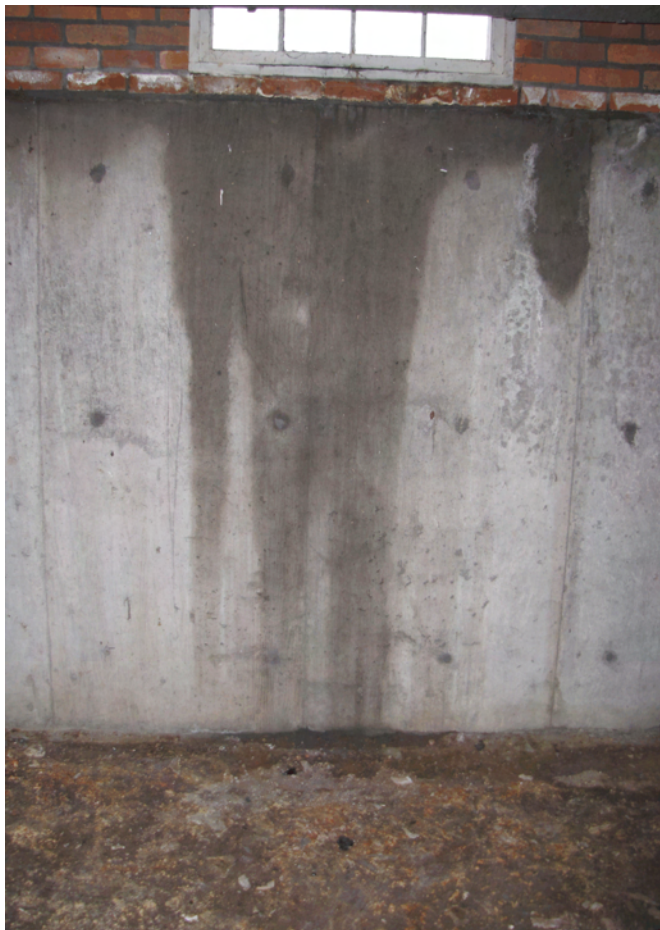
Photo 080: West wall of sanctuary basement showing dampness on wall from water infiltration at bottom of brick.

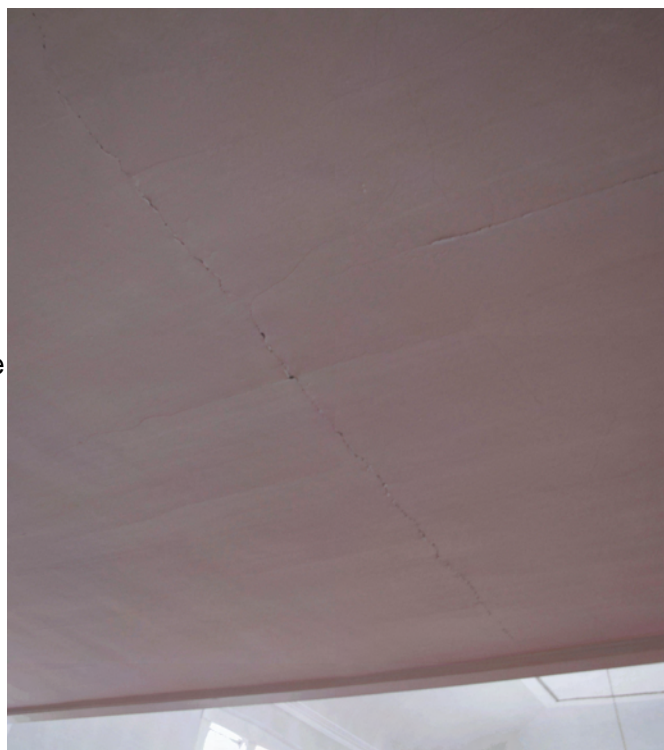
Photo 064: Cracking in plaster ceiling at the underside of the balcony.

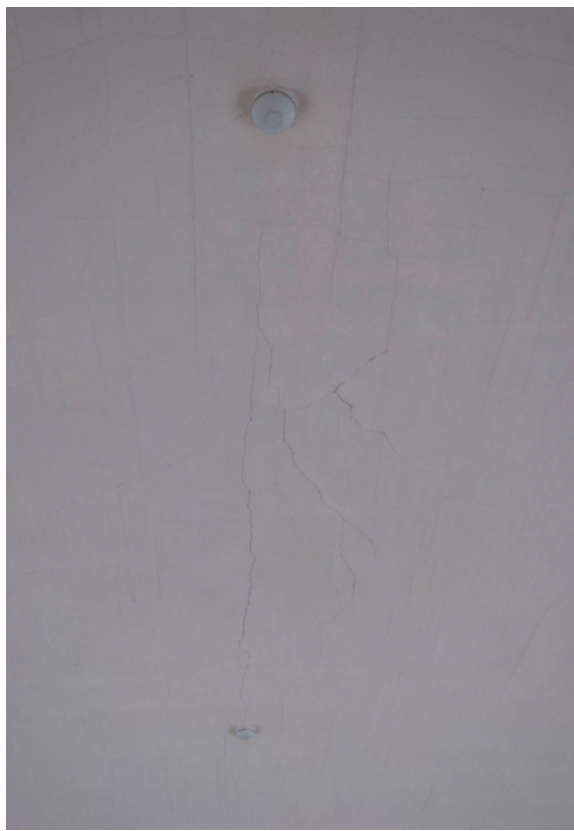
In addition to the cracking in the plaster resulting from deflections of the ceiling framing, several other factors are likely contributing to the cracking. During the winter in particular, the church space goes through cyclical temperature variations which will cause thermal expansion and contraction. The moisture or humidity levels in the sanctuary and attic space also vary with the intermittent use of the space. Both of these conditions can cause cracking of the plaster over an extended period of time (years) that the church has been existing.

Photo 060: Sanctuary ceiling plaster cracks between and around smoke detectors.

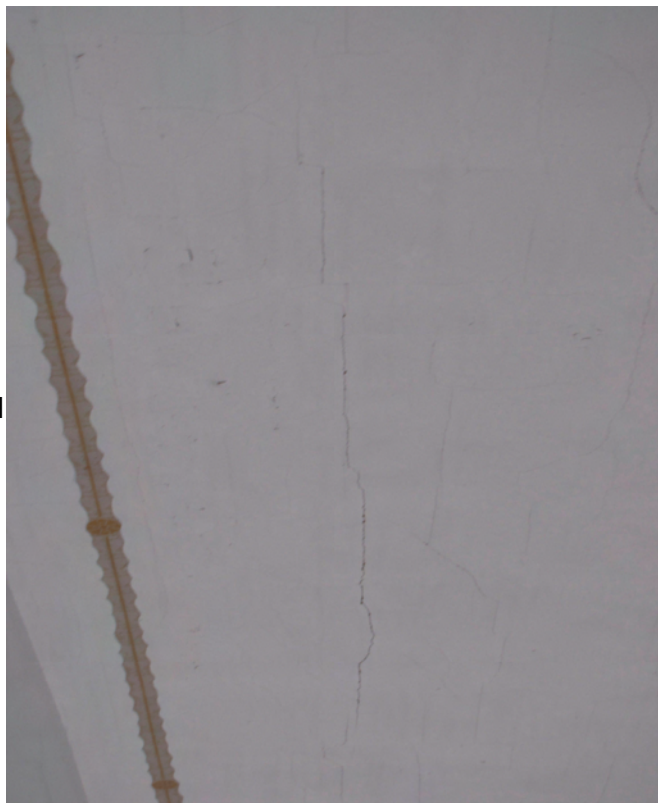
Second, the outer section of the slightly sloping ceiling joists have their bottom edge cut on a large radius curve to join the flat and tightly curved sections of the ceiling. The reduction in depth of the ceiling joists near mid-span of their length, reduces the stiffness of the joists and causes them to deflect more than if they had their full depth for their entire span. Further, at the west half of the ceiling, there are diagonal braces in a horizontal plane of the roof which interfere with some of the ceiling joists. At these interference points, the top half of the ceiling joists have been cut away so that the diagonal framing can pass through the joist. This also reduces the strength and stiffness of the joists, causing larger deflections. Both of these points are contributing to the cracking of the plaster ceiling at the east and west sides where the ceiling transitions from flat to curved.

Photo 061: Sanctuary ceiling plaster cracks running north-south, which occur at both east and west sides of the sanctuary.

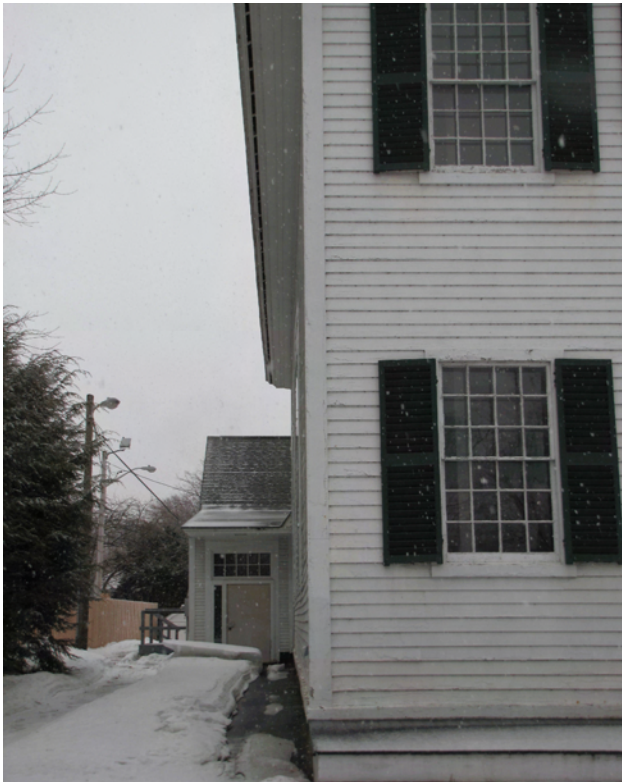
First, at the outer section of ceiling joists, where the ceiling curves down to the exterior walls, diagonal ceiling framing creates a horizontal push on the walls, as the slightly sloping ceiling joists, which support the upper end of the diagonal joists, deflect causing vertical downward movement. Geometrically, this creates the horizontal push on the exterior walls which is visible as a vertical bow in both the east and west exterior walls of the sanctuary.

Photo 022: Looking south along east wall of sanctuary with vertical bow in wall visible, which results from diagonal ceiling framing horizontal load component.

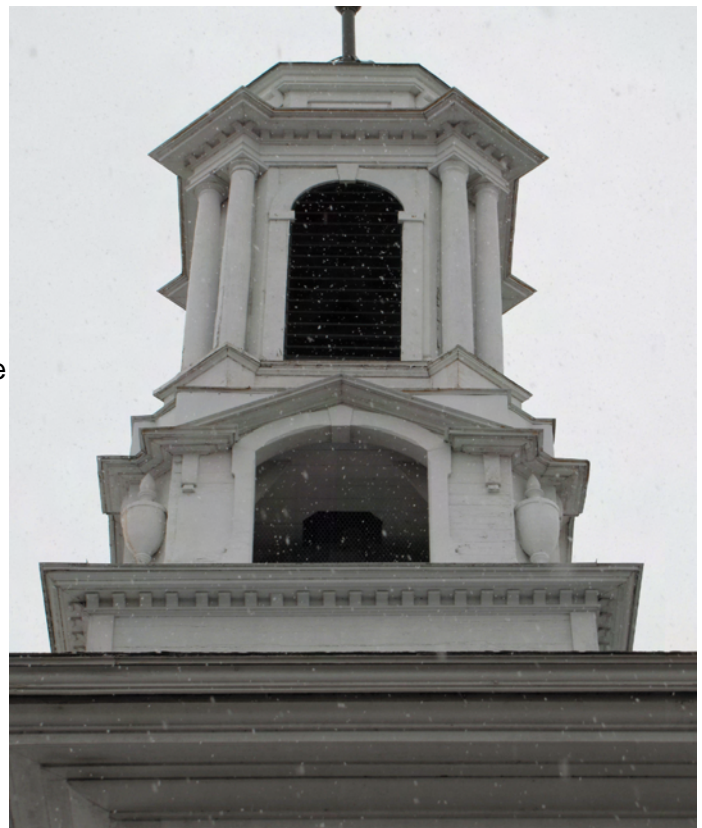
The steeple and cupola do have a slight tilt southward at the top. This results from the north framing aligning with the north wall of the church while the south framing extends down to transfer beams which deflect under the load of the steeple/cupola. The transfer beams span between the north

exterior wall and the first roof truss to the south. The tilt is caused by the transfer beam deflecting while the north wall framing does not deflect. While the tilt is noticeable to the trained eye, it is not excessive nor unexpected. No action is required for this condition.

Photo 014: Steeple and cupola, viewed from the west, showing slight tilt towards the rear of the building, as a result of interior beam support deflections.

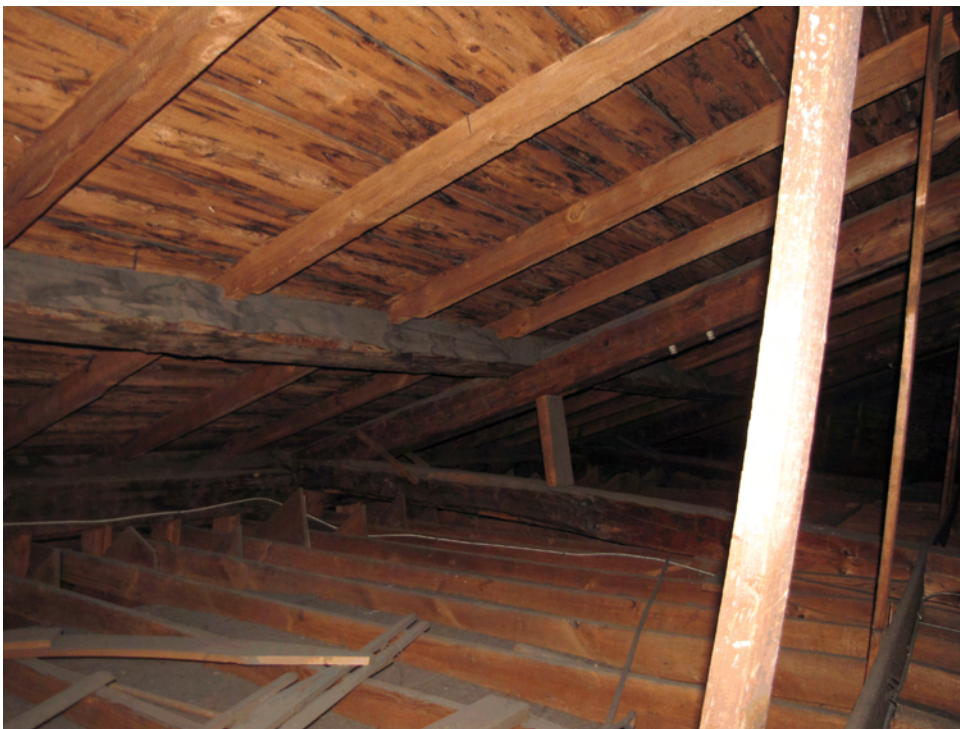
Photo 051: View of east portion of roof, looking south. Note that the ceiling joists have their bottoms cut on a curve, thereby reducing their depth and stiffness near mid-span. Vertical elements on right side of photo are hangers for board supporting the ceiling joists.

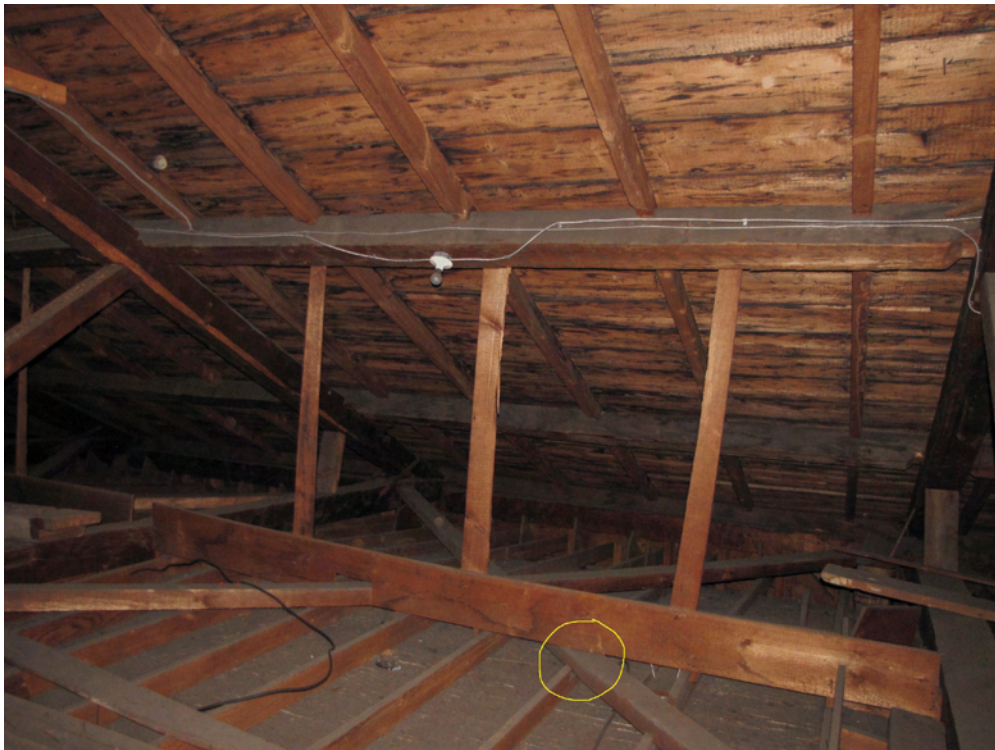
Photo 047A: Attic ceiling and roof framing looking west. Note ceiling joists are notched at diagonal bracing, in yellow circle, which reduces stiffness and increases deflections. Three vertical wood hangers support 1x12 on edge, which supports ceiling joists.

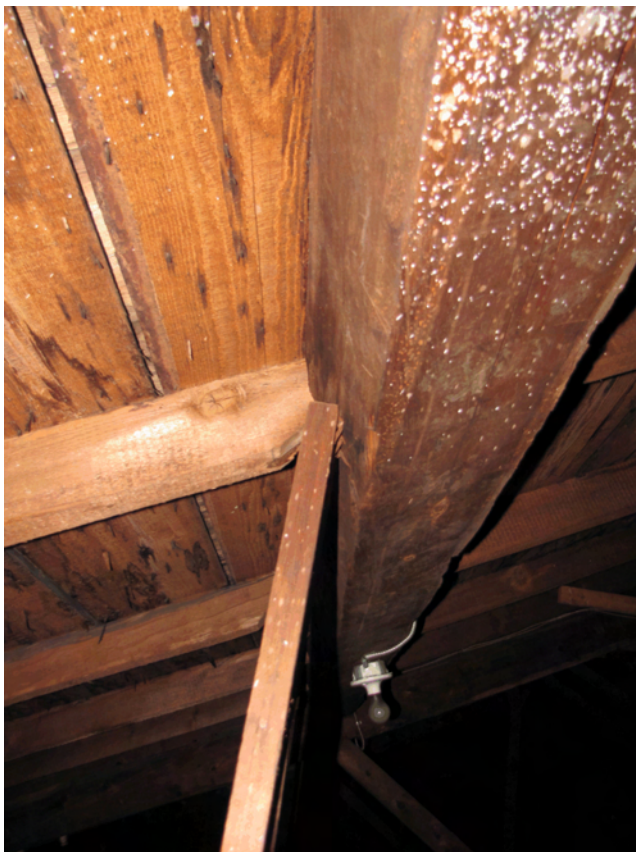
Third, the ceiling joists are supported by 1x12 vertically oriented boards spanning between trusses, which are in turn hung from the roof beams by two or three boards just nailed to the roof beams. Because the square roof beams are rotated to the slope of the roof but the hangers are vertical, the surfaces of the two meet at a point, not in a common plane. Therefore, the nails extend through some open space between the two members. This places bending forces on the nails which they do not usually experience and for which they are not designed. These nailed hanger connections should be backed up with the addition of some metal strap ties which are nailed to the vertical hangers and wrap over the top and down the opposite side of the roof beams, being nailed to both. Loss of the existing hanger nailed connections due to pull out of the nails would likely result in the loss and collapse of some large sections of ceiling. If the sanctuary is occupied at that time, there would likely be injuries or worse. If the sanctuary is unoccupied, there would be damage to the pews and floor.

Photo 043: Representative wood hanger connection to wood roof beam. Nails from hanger to beam are sloped down and away from the beam, suggesting they are pulling out over time.

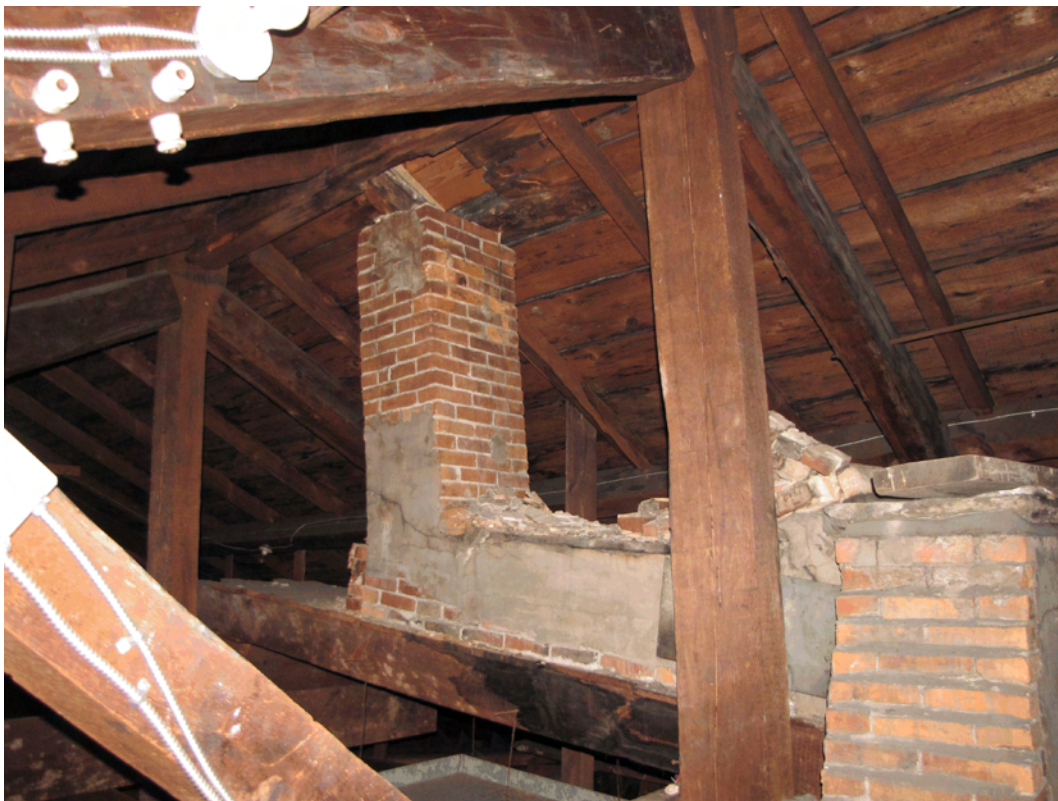
There is an old brick masonry chimney in the attic space located between, and supported by, the two northerly timber roof trusses. The chimney has been taken down to just below the roof rafters, but the bulk of it is still in place. It would be prudent to remove the upper vertical section and the sloping horizontal section to remove unnecessary dead load from the roof trusses, particularly the truss carrying the hung balcony. This action can remove some of the dead load deflection from one truss. Any opening at the top of the remaining chimney should be covered over.

Photo 024: Old unused brick chimney should be removed to reduce weight on structure.
