TIREY & ASSOCIATES, P.C.

CONSULTING STRUCTURAL ENGINEERS

March 22, 2011

RE: First Congregational Church Structural Condition Evaluation, Lebanon, NH

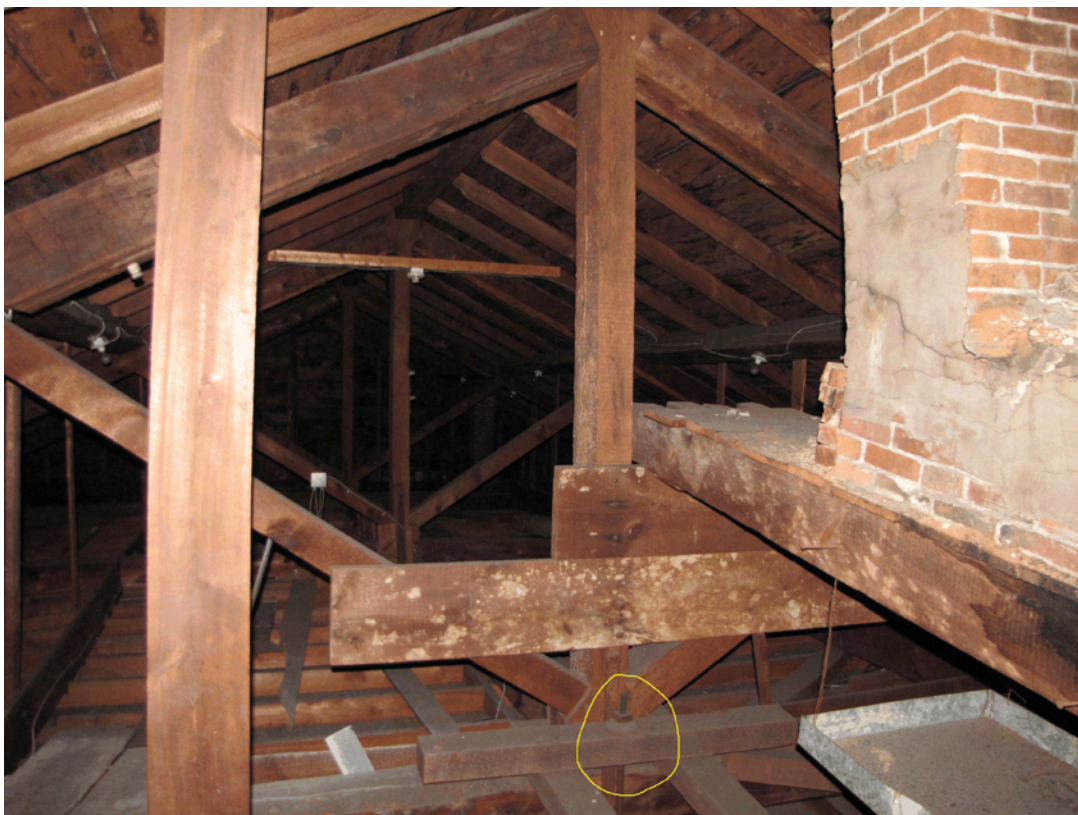
There is an old brick masonry chimney in the attic space located between, and supported by, the two northerly timber roof trusses. The chimney has been taken down to just below the roof rafters, but the bulk of it is still in place. It would be prudent to remove the upper vertical section and the sloping horizontal section to remove unnecessary dead load from the roof trusses, particularly the truss carrying the hung balcony. This action can remove some of the dead load deflection from one truss. Any opening at the top of the remaining chimney should be covered over.

Photo 025A: View showing support of unused brick chimney on truss, plus top of balcony hanger rod in yellow circle.

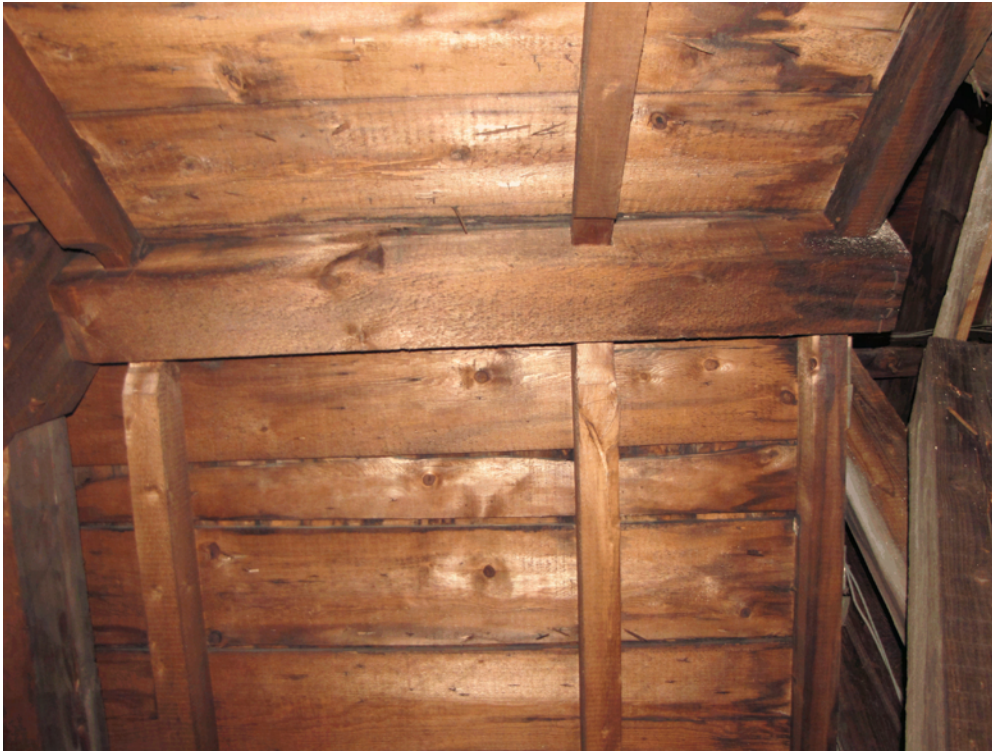
A short ridge beam running from the north roof truss to the south wall of the steeple/cupola has lost its post support at its north end. The post appears to have fallen away from the ridge and needs to be put back in place with suitable connections (more than just nails).

Photo 026: Short ridge beam between 1st roof truss from north wall and steeple/cupola wall framing. Right end of ridge beam is unsupported.

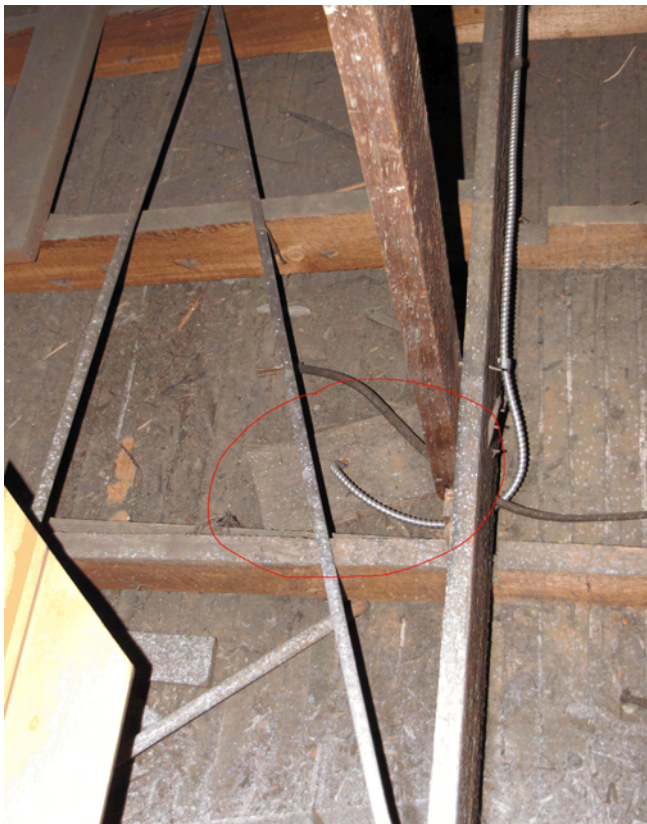
Photo 059A: Attic ceiling framing with electric wire at center in red circle feeding hung chandelier in sanctuary. Note that added wood plate from which the chandelier is supported, is in turn only supported by the wood lath, not the ceiling joist framing.

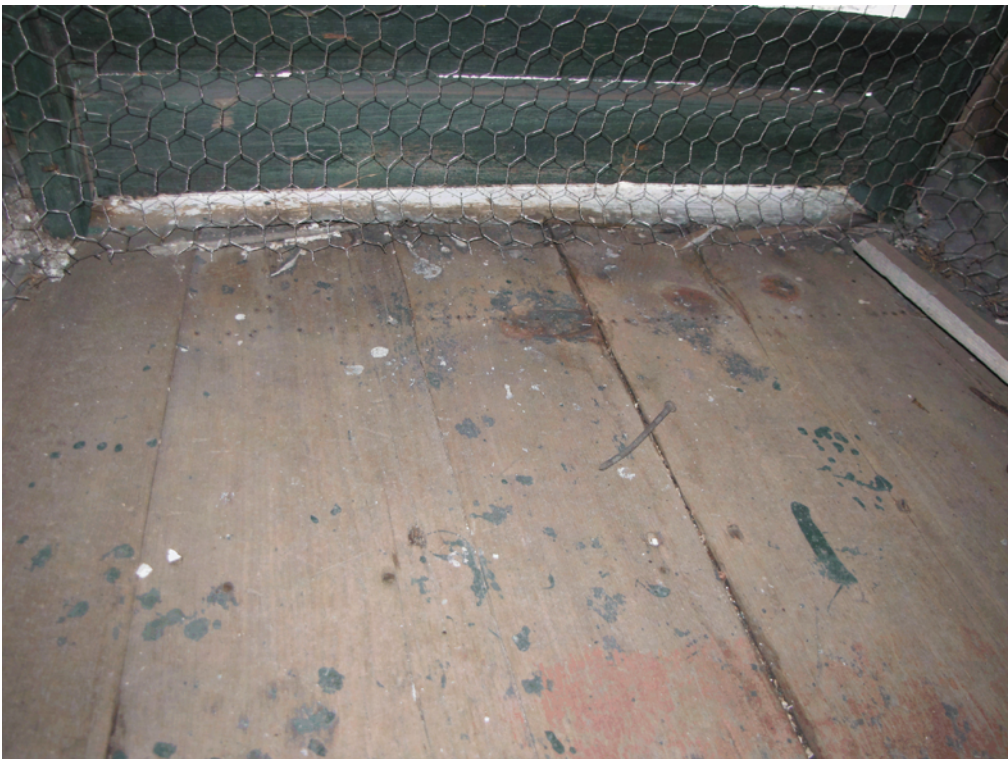
The roof structure over the church bell has board sheathing which is not protected by a roof membrane. The walls above have flashing at their bases, but the flashing just extends down to the wood roof sheathing. This condition can allow wind blown water and snow to land on the wood roof sheathing and make its way down into the structural framing, potentially causing rot of the wood. While there is not specific evidence of rot occurring in the structure yet, it would be appropriate to waterproof this wood roof to protect it against water infiltration and damage.

Photo 031: Roof over bell showing exposed wood plank roof which is highly susceptible to wind blown rain/moisture.

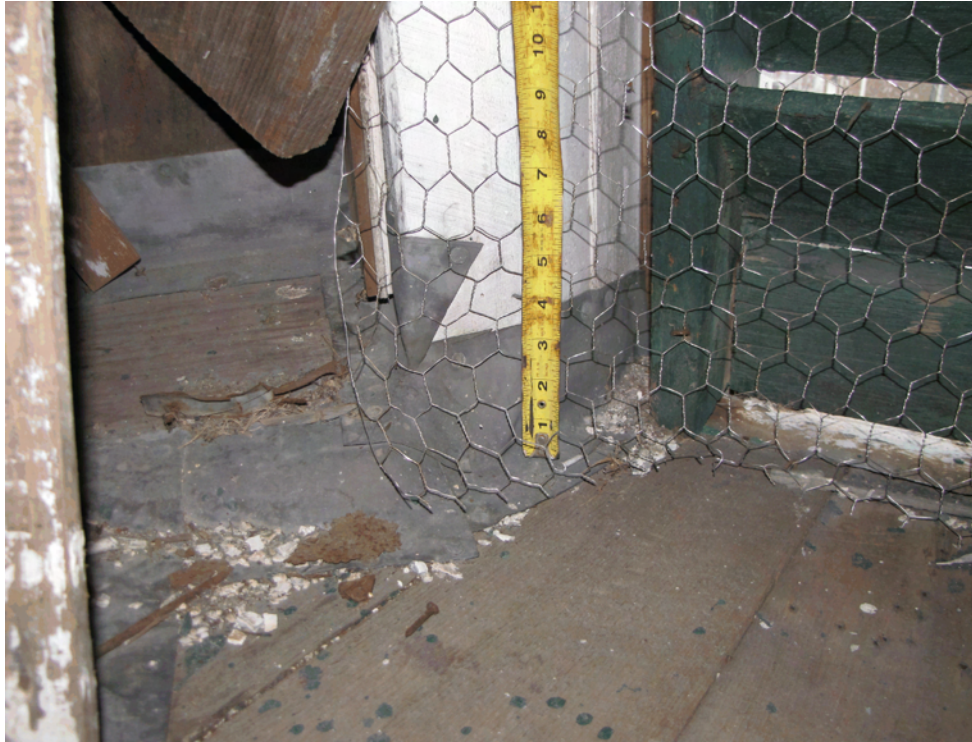
Photo 032: Flashing around corner posts at walls below upper cupola. Note flashing extends down to wood roof boards. There is no waterproof membrane on this partially protected roof.

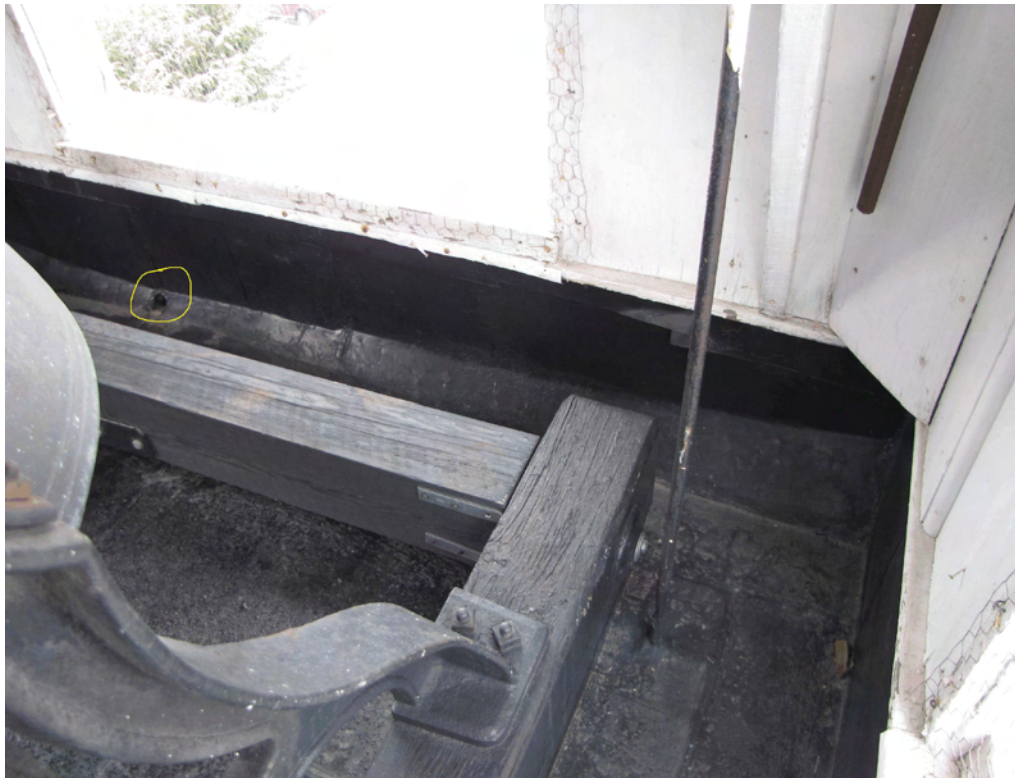
At the floor framing that supports the church bell, there is a waterproofing membrane to protect the underlying floor framing. There is one drain hole through the south wall, just above the floor level. It appears that the floor to either side of the drain holes slope slightly down and away to the east and west sides of the steeple. This would make draining of water difficult and leave standing water on the floor area after wind blown rains. It would be prudent to verify the drain height with respect to the floor level and add drains if necessary at low points on other walls.

Photo 033A: Floor of bell area. Note drain hole for water in yellow circle, located at the south wall of the steeple, is at the high point of the sloped framing, reducing the effectiveness of the drain.

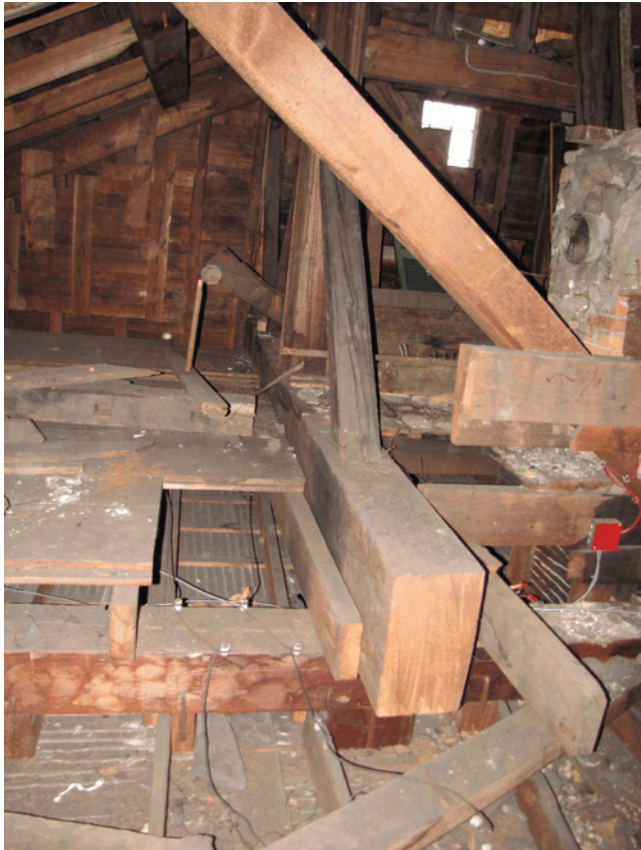
All of the primary roof trusses are constructed in the same manner and with the same size timbers. The truss closest to the north exterior wall of the building though, has at least two interior post supports that the remaining trusses to the south do not. This creates a deflection differential between these trusses because the west truss span is short compared to the other trusses. The next truss to the south of the northern most truss also has the additional load of the hung balcony suspended at midspan of the truss. This additional load creates additional deflection that the other identical trusses do not have. As a result, there is a very noticeable belly (excessive deflection) in the roof at the truss location supporting the balcony. It may be prudent to perform an analysis of this second truss from the north wall to verify that it has capacity to carry the imposed loads.

Photo 099: View looking north in attic, showing transfer beam that supports steeple/cupola framing bearing on bottom chord of roof truss (running right-left near bottom). Note this roof truss has interior post supports beneath it, making deflection differentials between it and the next truss to the south (supporting the balcony) more pronounced and greater. Note lack of any insulation on top of the plaster and lath ceiling.
