TIREY & ASSOCIATES, P.C.

CONSULTING STRUCTURAL ENGINEERS

March 22, 2011

RE: First Congregational Church Structural Condition Evaluation, Lebanon, NH

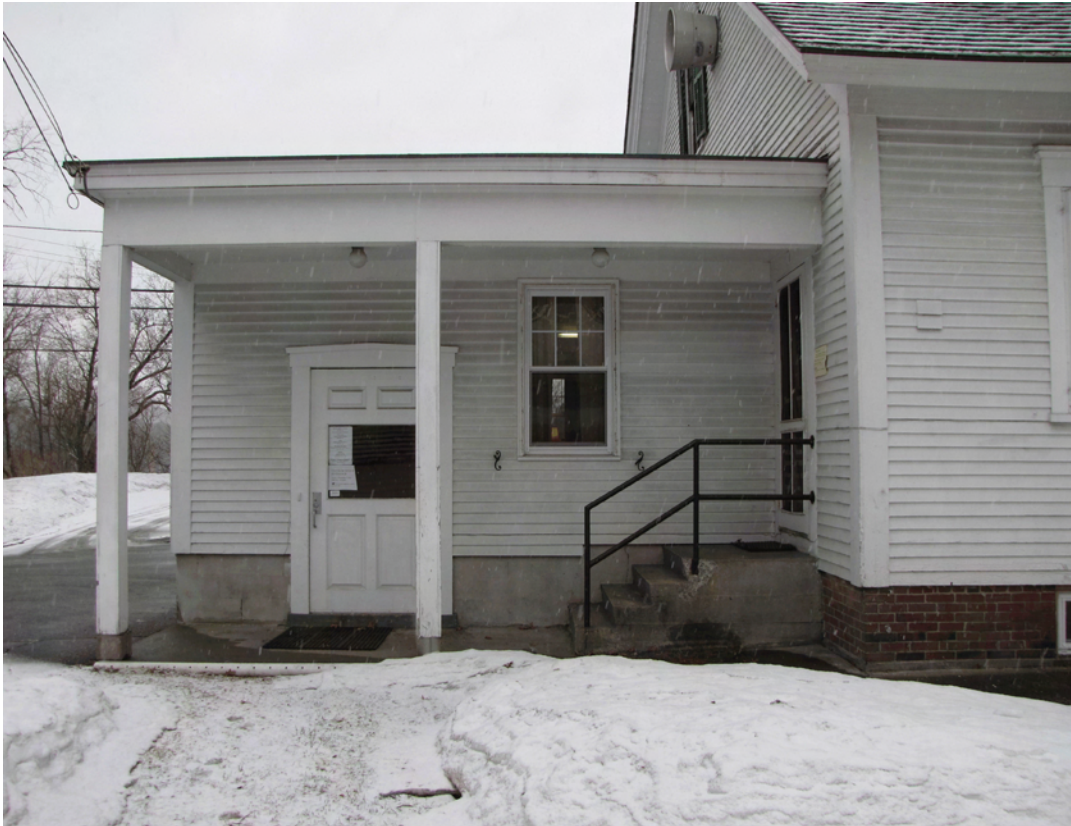
Photo 005: View of east side of 1960's addition and south end of 1920's addition with stair leading into it.

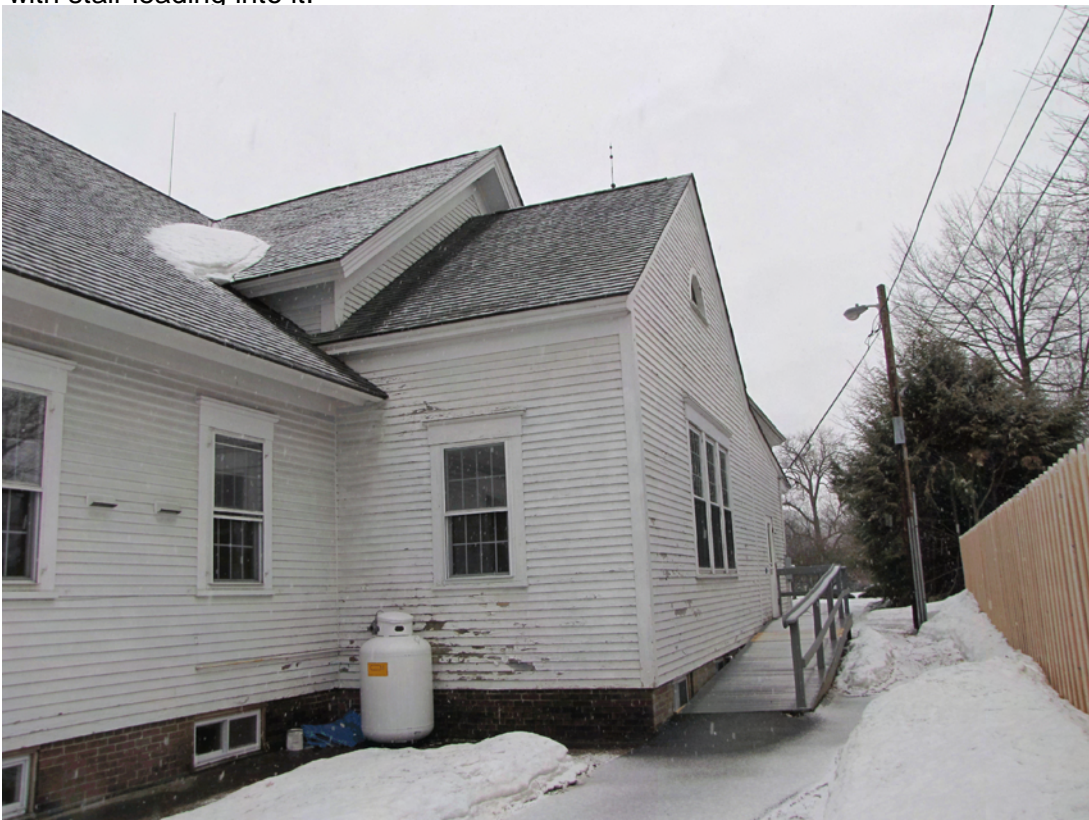
Photo 007: View of 1920's addition, east side.

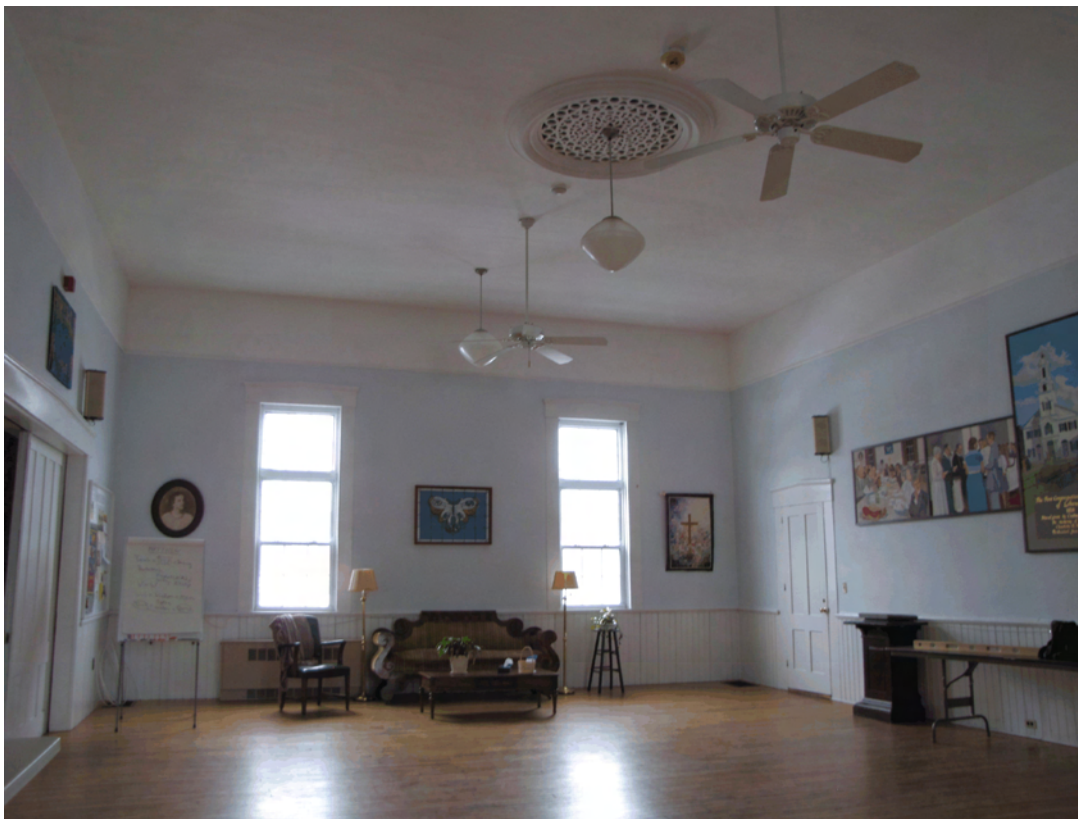
Photo 097: Interior view of 1920's addition looking west. Walls and ceiling are in good condition. Hump in floor is not easily seen in this photo.

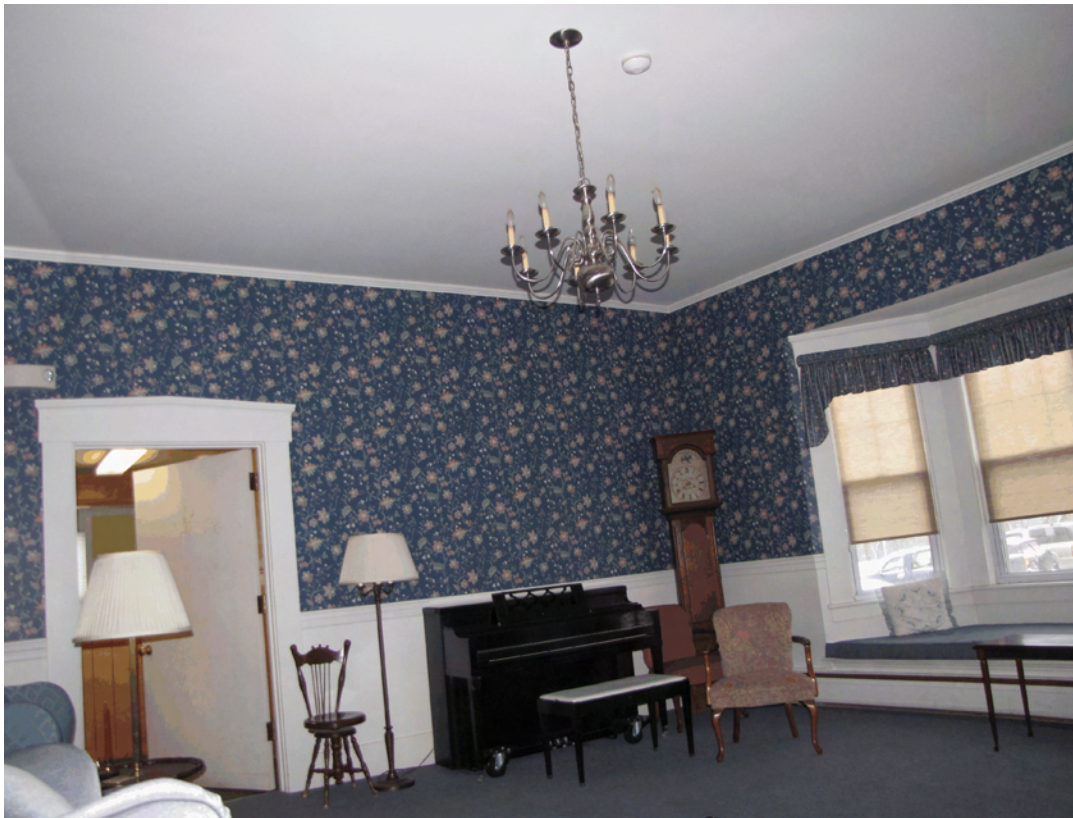
Photo 093: Interior view of 1920's addition at southwest room, with everything in good condition.

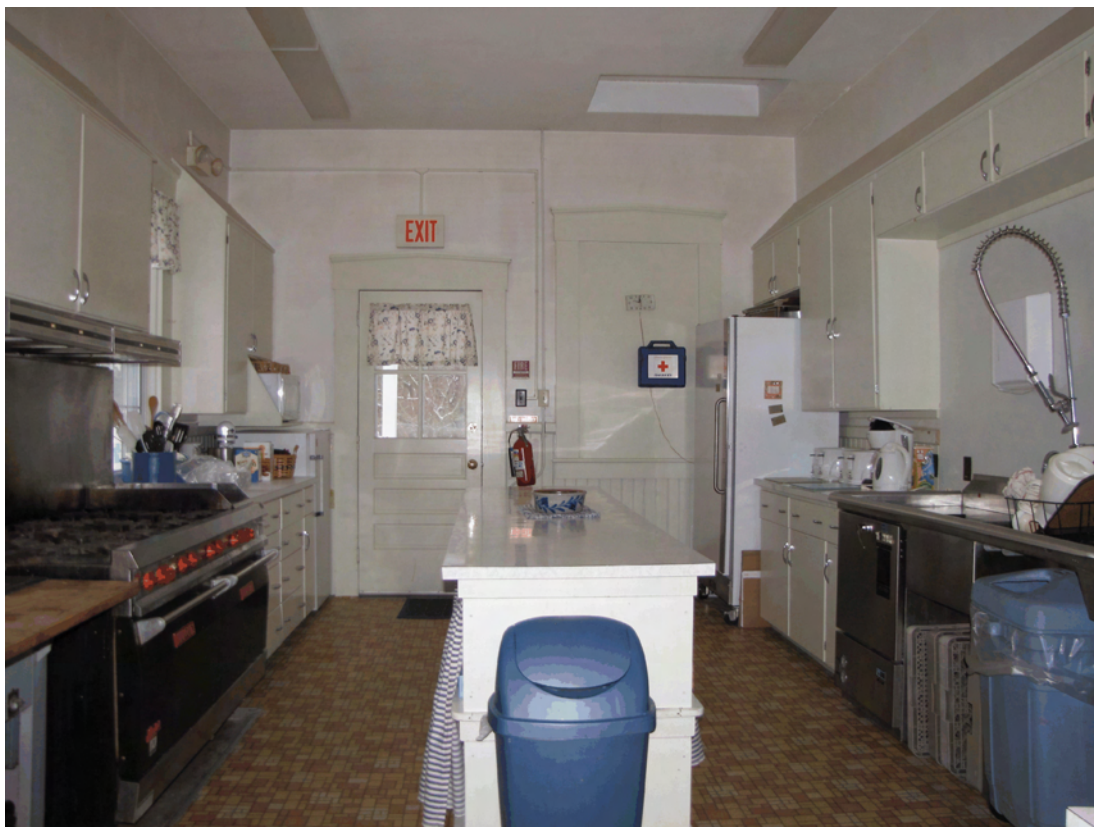
Photo 095: Kitchen area of 1920's addition, with everything in good condition.

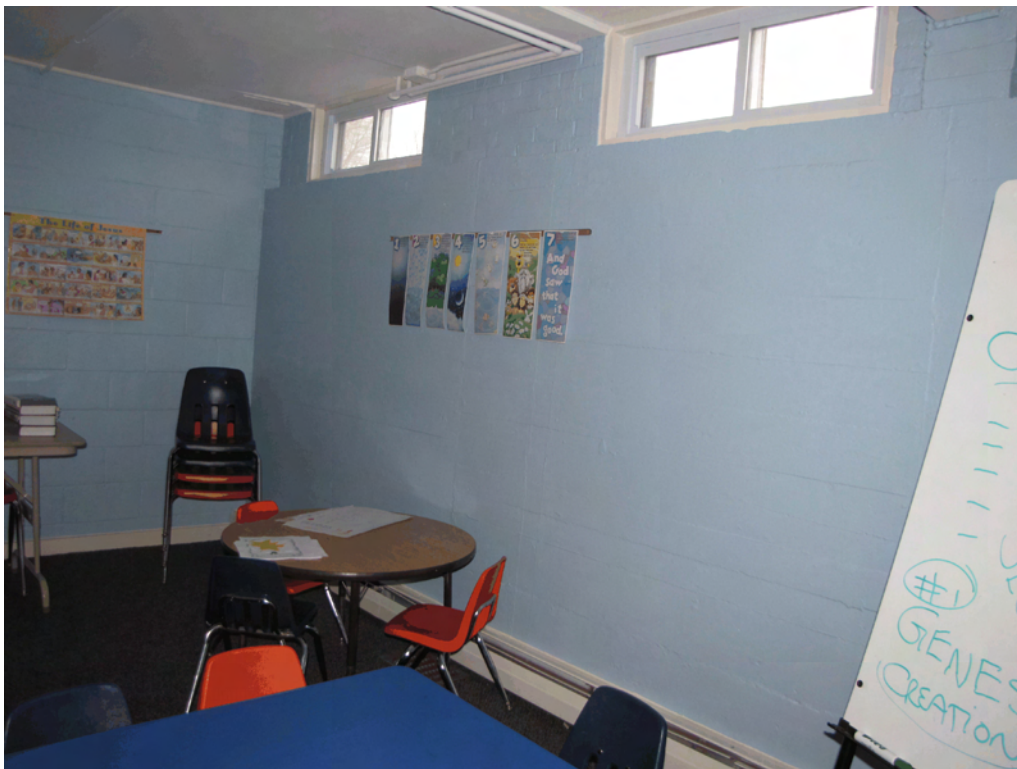
Photo 086: Representative exterior foundation wall, at west side, showing good condition of concrete and brick above (to sides of windows).

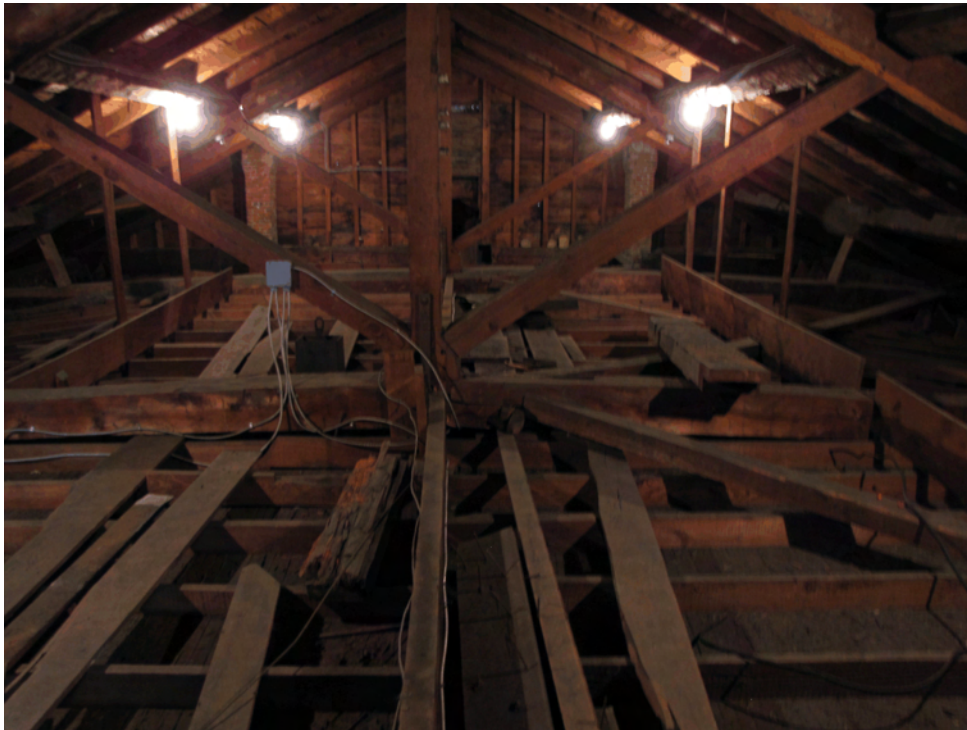
Photo 054: Interior view of sanctuary roof framing looking south. Heavy timber roof trusses clear span the sanctuary in an east-west direction. Note the ceiling joist framing with lath (for plaster) directly attached and no insulation.

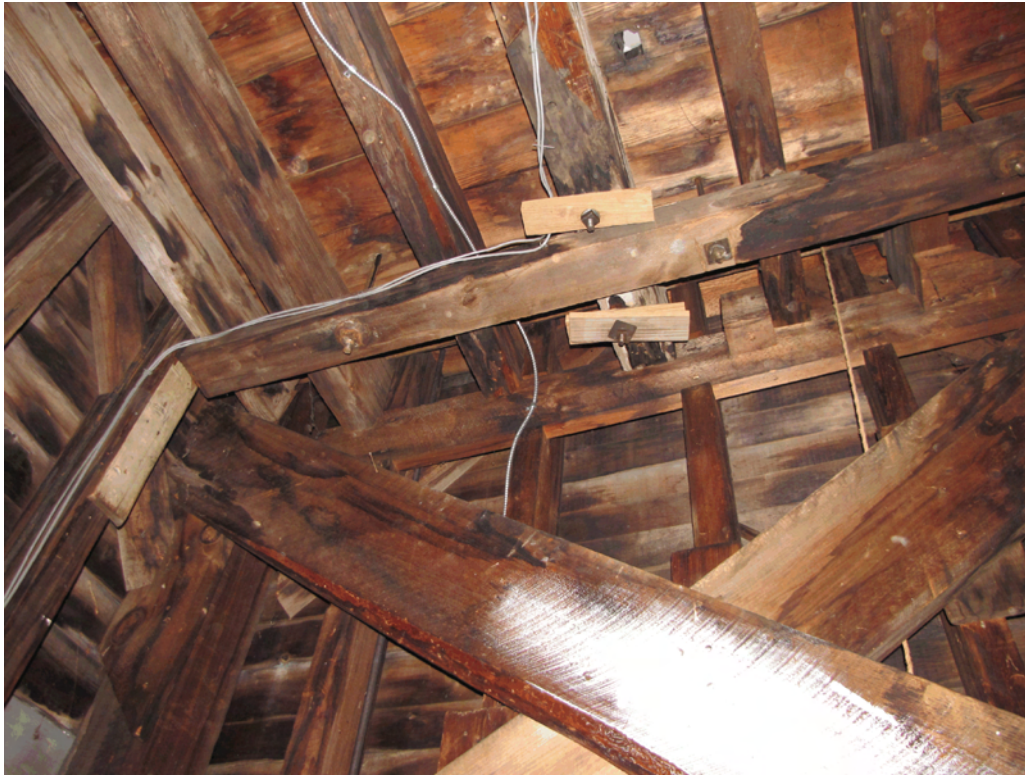
Photo 035: Under side of bell floor framing at steeple/cupola, showing tension rods in wall to resist structure overturning and rod bottoms in upper half of photo which tie the upper cupola framing down. Note wood framing appears to be in good condition.
